# BRE Global Client Report

**BS 8414-1:2015 + A1:2017 test referred to as DCLG test 4.**

**Report Number:** B137611-1037 (DCLG test 4) Issue: 1.2

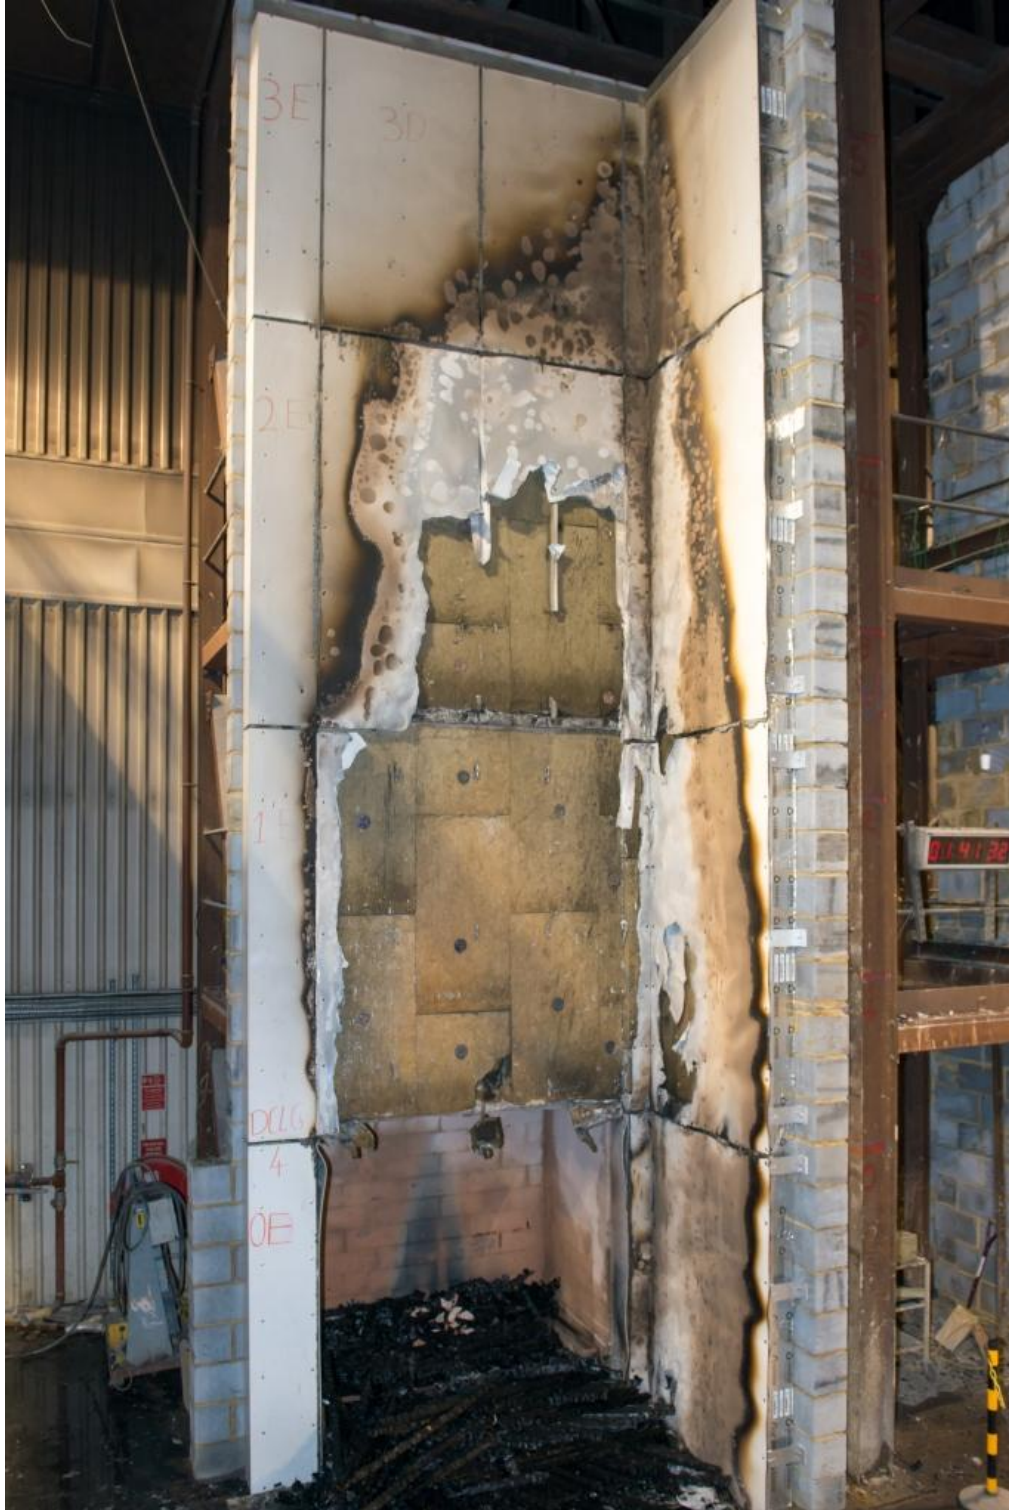
The cladding system was damaged across the full height – see *Figures 21-35*. The extent of the damage increased from black discolouration of the ACM panels at the edges of the flame damage zone to complete consumption of panels, rail substructure and substantial discolouration of the insulation directly above the combustion chamber opening up to a height of approximately 3600mm – see *Figures 21-35*. The wing wall was less severely damaged than the main wall with small areas of panel consumption (total area <0.6m<sup>2</sup>) up to the height of the first cavity barrier and significant ACM panel discolouration up to the height of the third cavity barrier, which reduced in severity towards the top of the cladding system – see *Figures 21-27*. Beneath the ACM panels on the wing wall, insulation discolouration (concentrated in the region of panel consumption) was limited to below the height of the third cavity barrier and, with the exception of the area between the second and third horizontal cavity barriers, on the main wall side of the central 'L' rail – see *Figures 31-35*.

Figure 21. Full height photograph of system post-test.

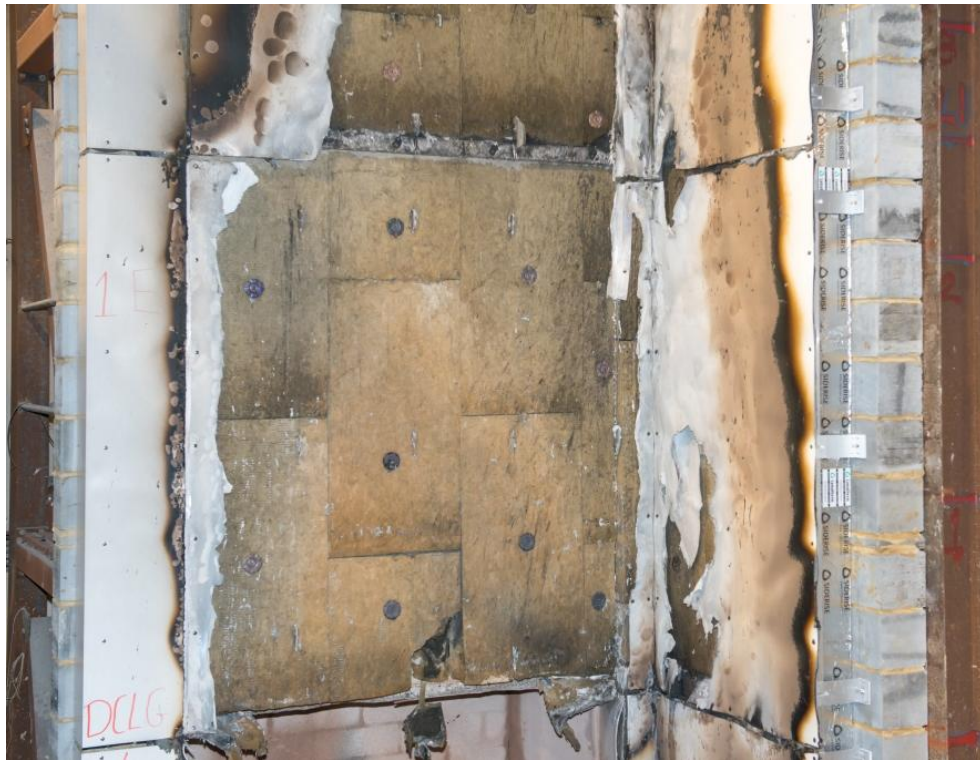
Significant discolouration and distortion was sustained by panels: 0A (90%), 1A (90%), 2A (70%) and 3A (30%) – see *Figures 21-25*. The damaged area tapered, in the direction of the main wall, from the outer edge of the wing wall (approximately 1.2m above the height of the combustion chamber) to the wing-main wall junction at the top of the cladding system – see *Figure 22*.

Figure 23. First row ACM panels (directly above combustion chamber).

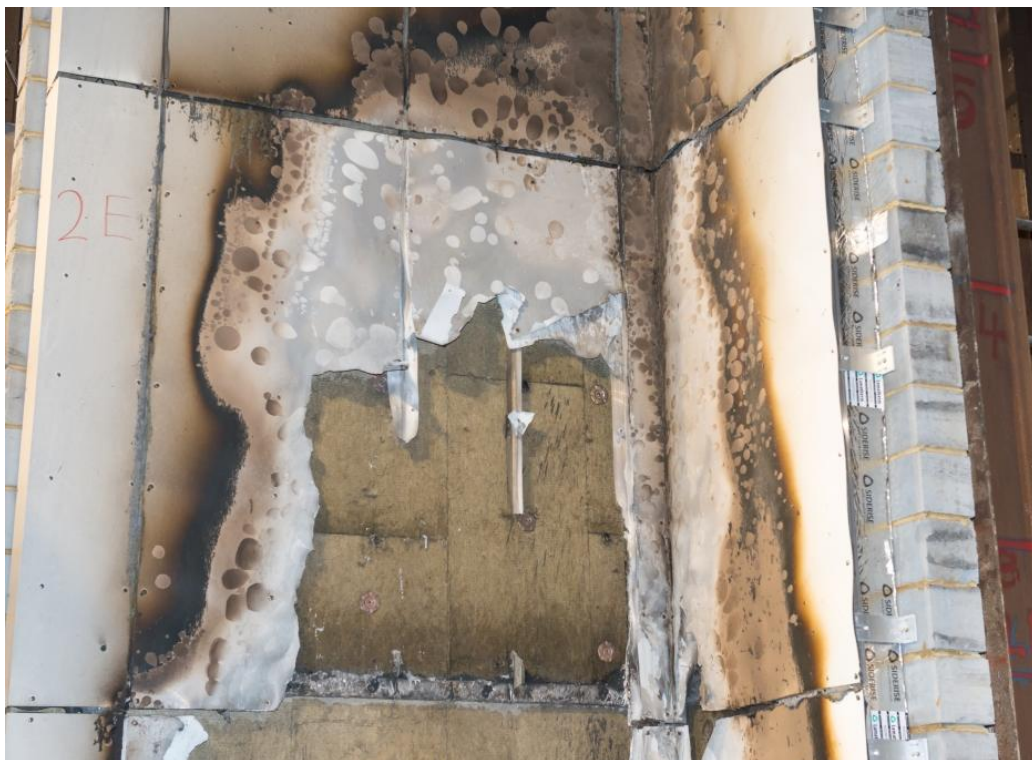
Figure 24. Second row ACM panels (approximately 2300mm-4600mm above combustion chamber).

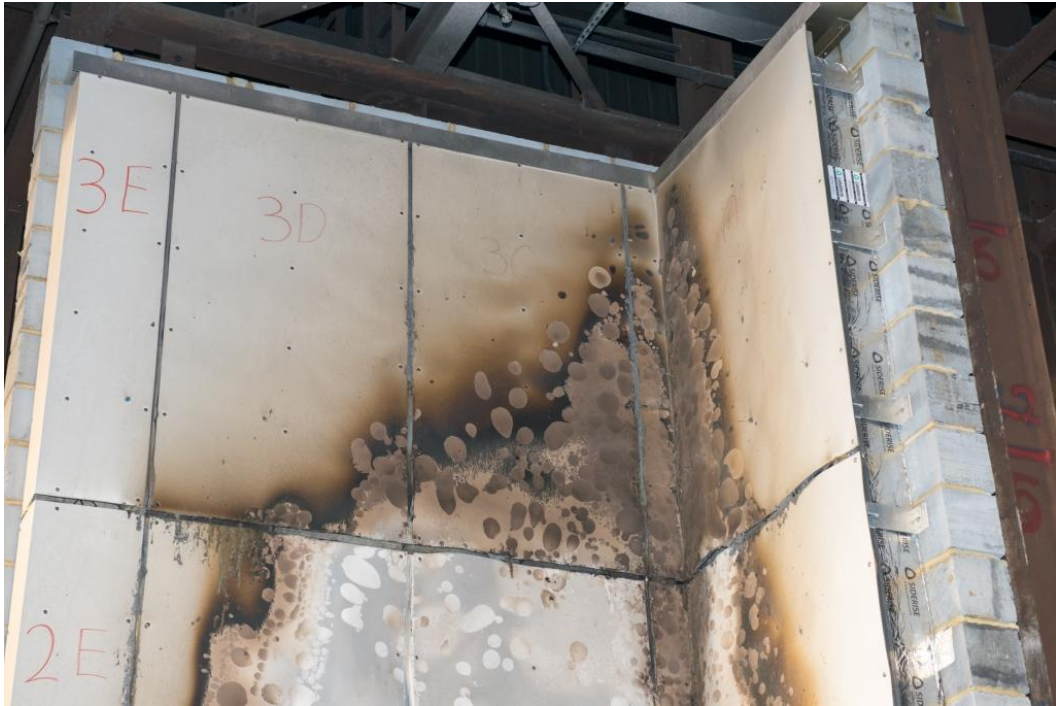
Figure 25. Third row ACM panels (approximately 4600mm-6500mm above combustion chamber).

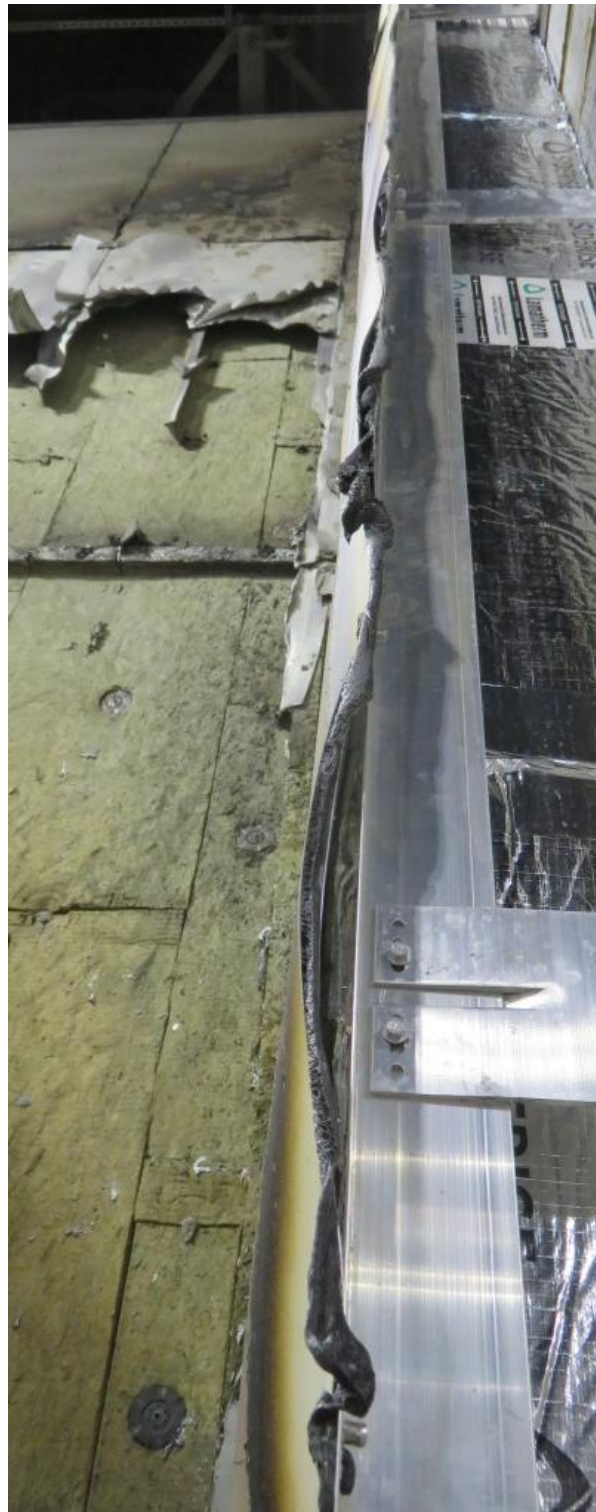
Figure 26. Close up of ACM panel edges showing melted core filler material.

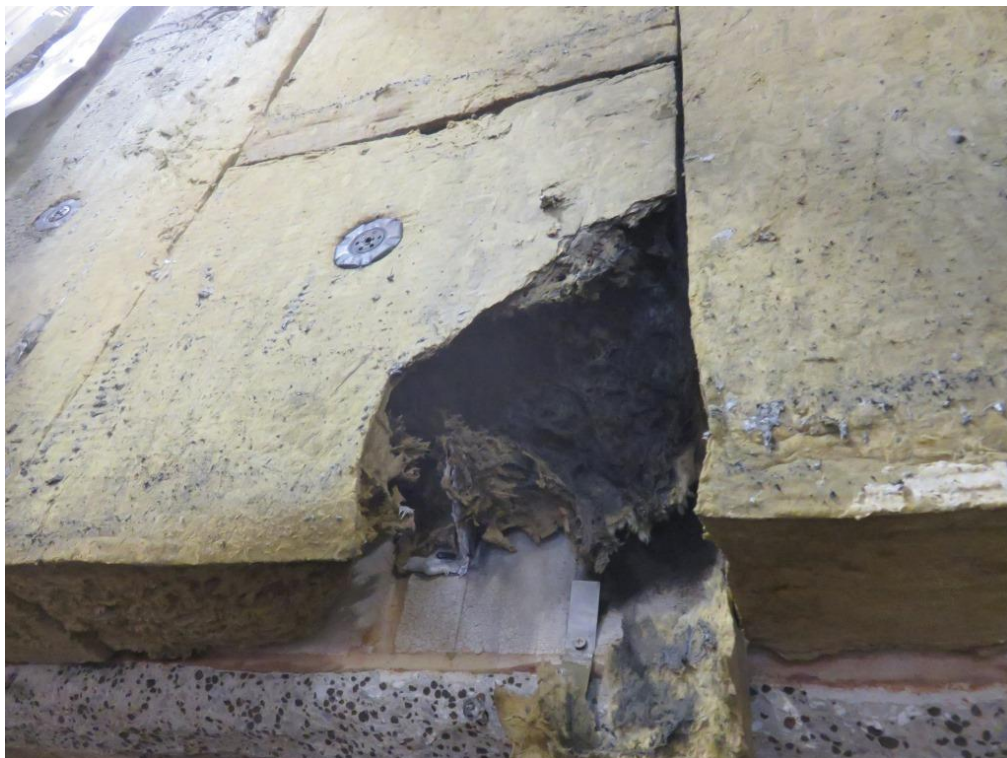
Figure 28. Close up of detached section of stone wool insulation directly above the combustion chamber.

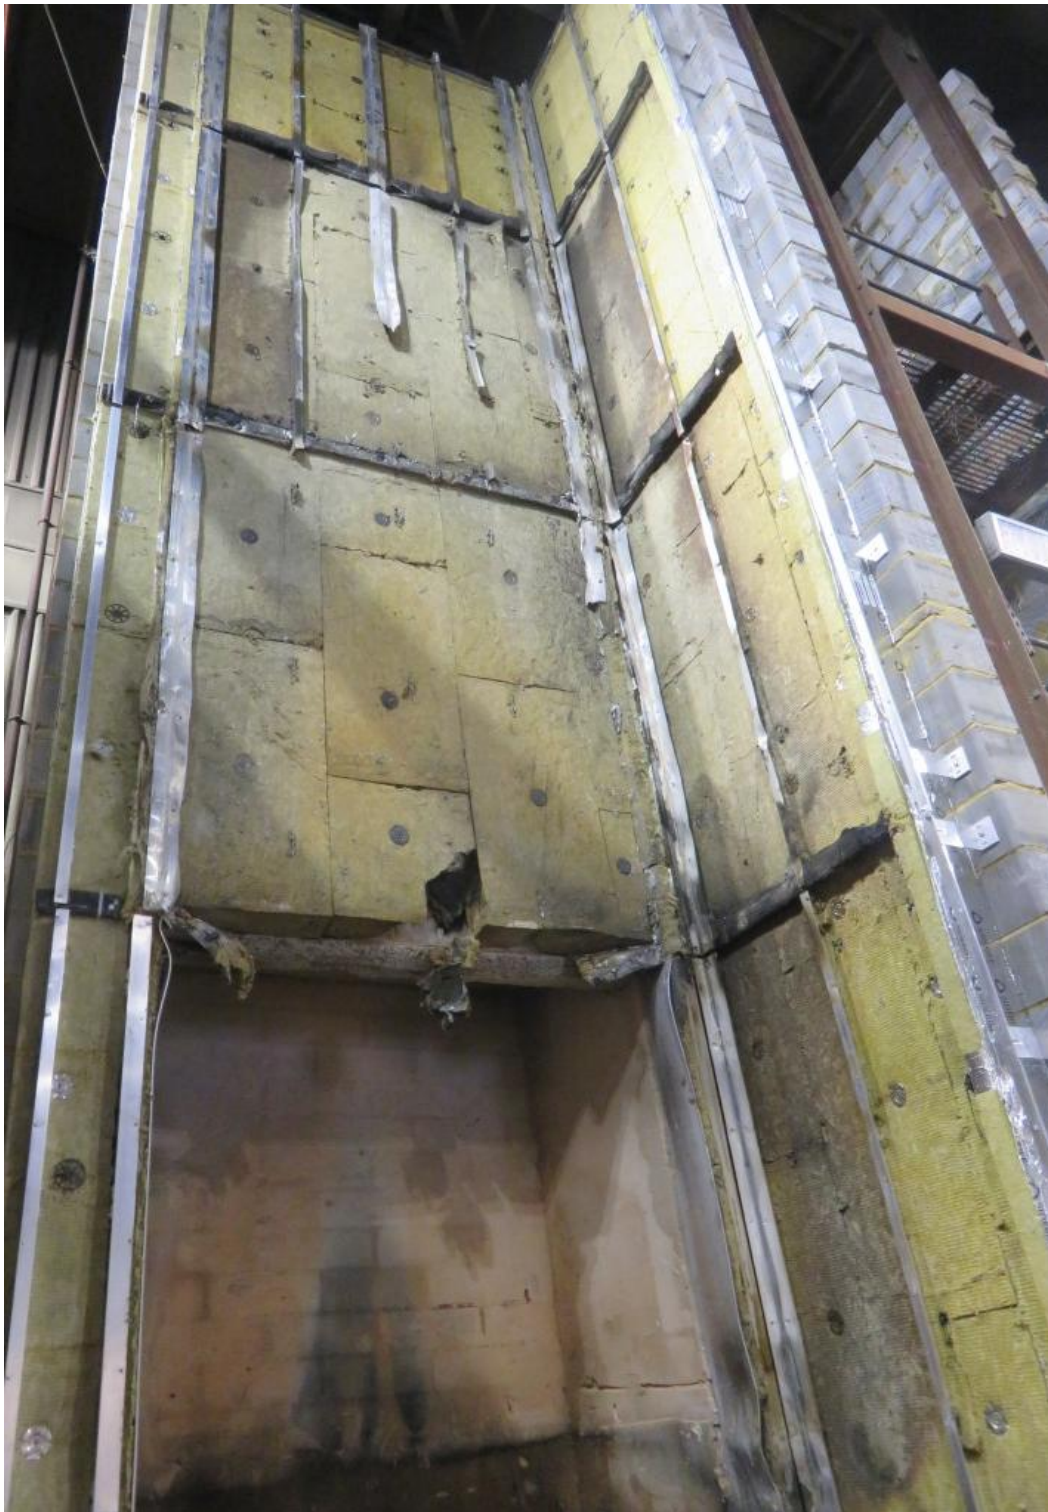
Damage to the rail substructure was most severe on the main wall with four of the five sections spaced evenly across the combustion chamber opening sustaining significant consumption – see *Figures 29-30*. At 500mm intervals from the edge of the combustion chamber adjacent to the wing wall the following damage occurred:

Damage to the rail substructure on the wing wall was far less severe – see *Figure 29*. Between the first and the third cavity barrier, two of the 'L'-rail sections (one immediately adjacent to the main wall, and the other at mid-width) sustained localised areas of discolouration and distortion – see *Figure 29*. The rail substructure above this, and at the outside edge (full-height) of the vertical cavity barrier appeared undamaged *Figure 29*.

Figure 29. Full height photograph of cladding system following removal of ACM panels.

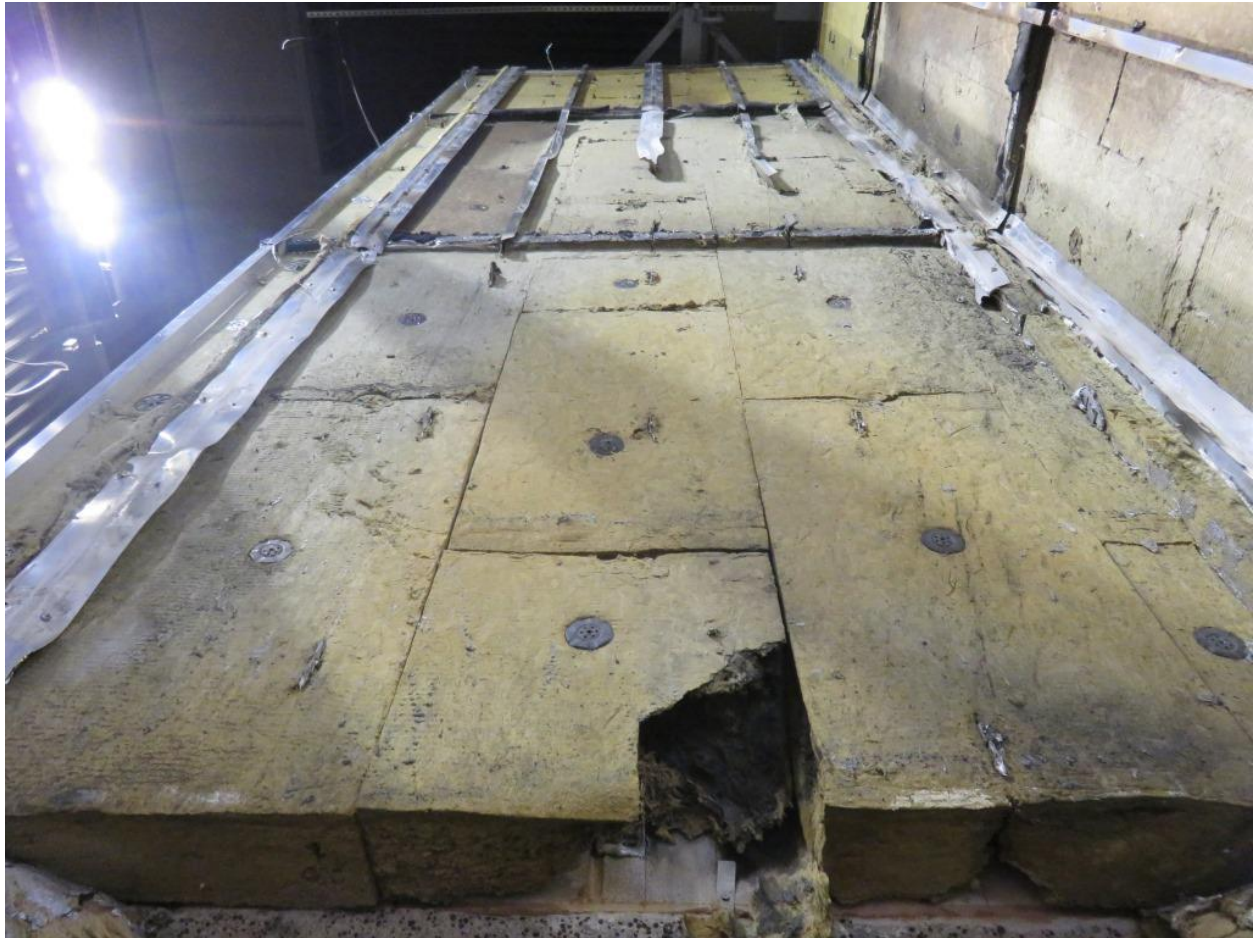
Figure 30. Damage to cladding system beneath ACM panels directly above the combustion chamber.

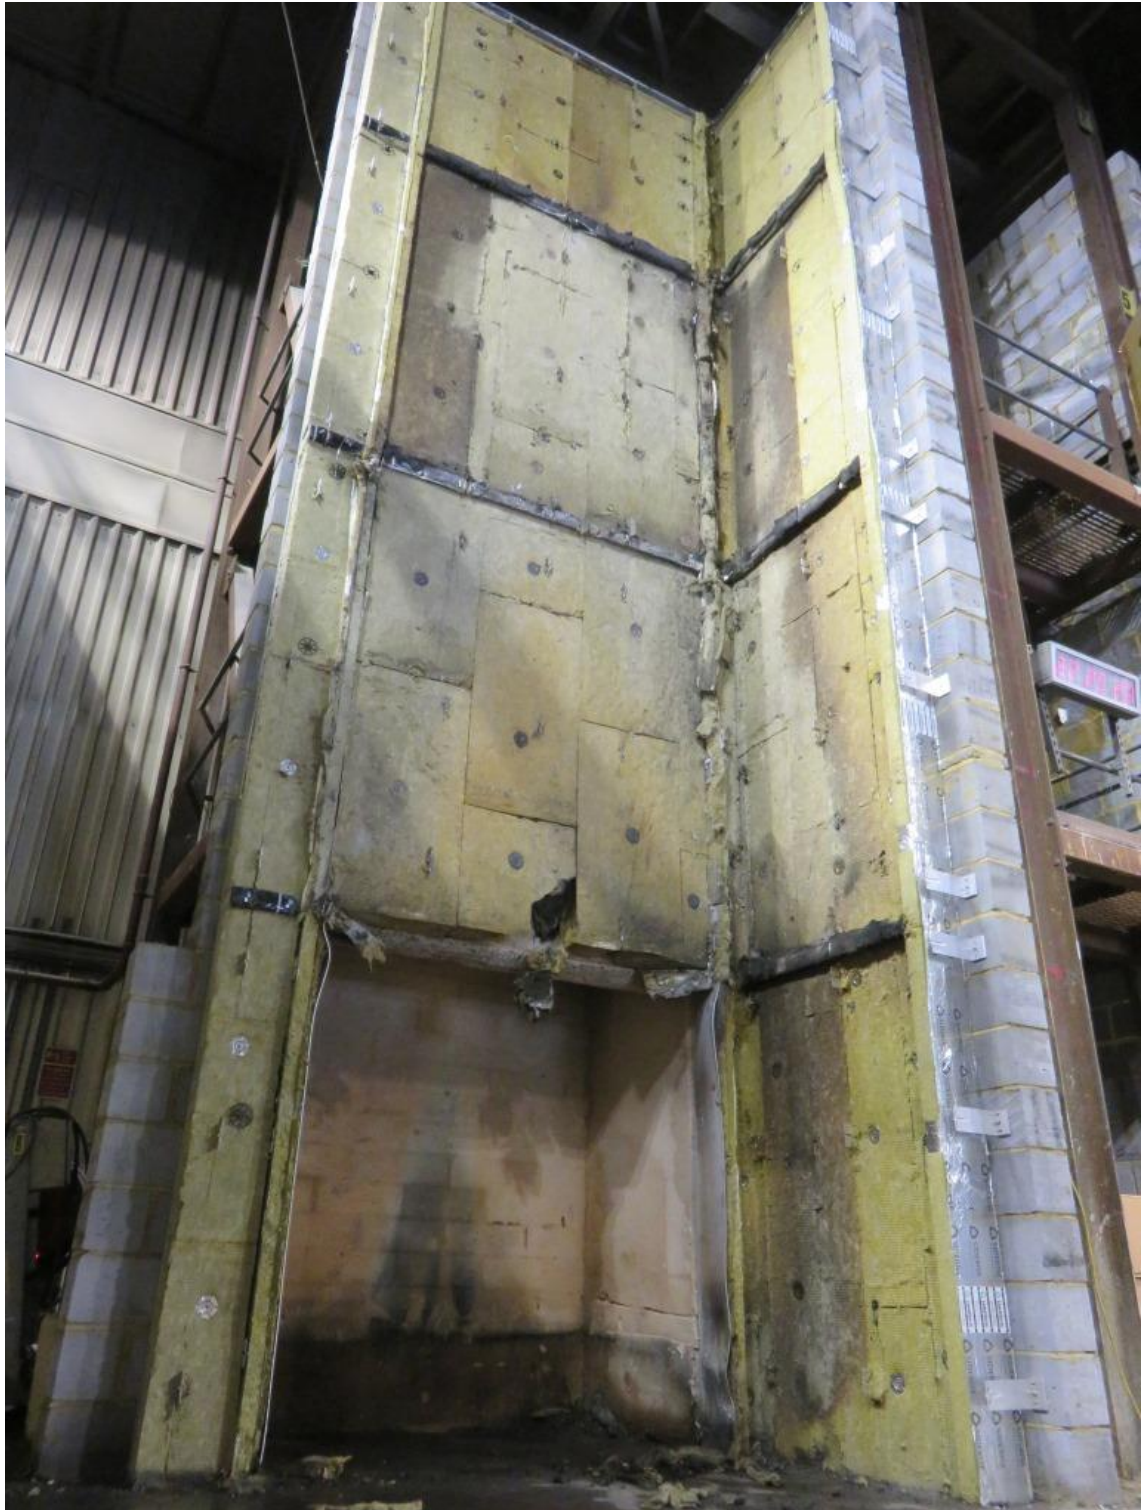
No discolouration was observed outside the outer main wall vertical cavity barrier. Minimal discolouration was observed, with the exception of the area between the second and third horizontal cavity barriers, beyond the central 'L'-rail on the wing wall – see *Figures 31-35*.

Full-width activation of the intumescent strip occurred on the wing wall with detachment of the expanded material observed between the main wall and the central 'L'-rail – see *Figures 31-33*.

Activation of the third row of horizontal intumescent cavity barriers occurred across the full width of the combustion chamber opening and the wing wall – see *Figures 31, 32, 34&35*. Detachment of the intumescent material was observed in line with the central 500mm of the combustion chamber opening and in a section 150mm-long approximately 100mm from the main wall. Partial activation occurred in the section of cavity barrier located at the outer edge of the main wall.

Figure 31. Full height photograph of cladding system following removal of ACM panels and rail substructure.

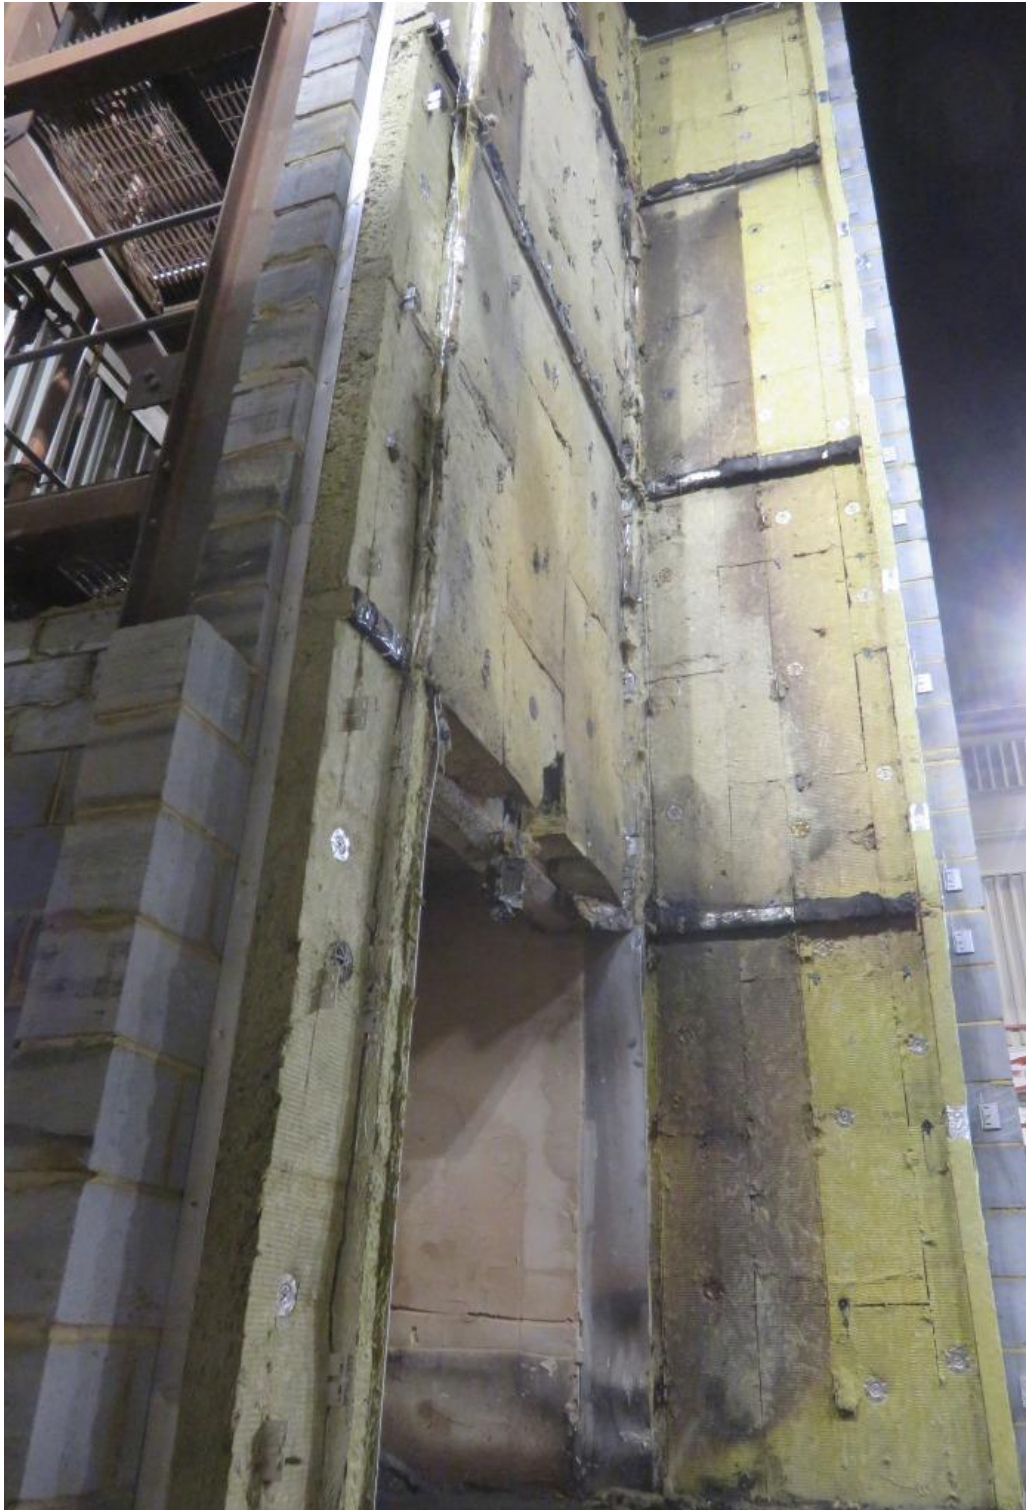
Between the second and third horizontal cavity barriers, the pale/bleached appearance of the stone wool insulation spanned the region, approximately 1500mm-wide, between the 'L'-rail (500mm from the outside edge of the combustion chamber opening) and the 'T'-rail (in line with the inside edge of the combustion chamber opening) – see *Figures 31&34*. Dark discolouration was observed on the remaining area in line with the combustion chamber opening and, on the wing wall, between the main wall and the central 'L'-rail – see *Figures 32&34*.

At ground level, dark discolouration was observed on the wing wall between the main wall junction and the central 'L'-rail – see *Figures 32*.

Figure 32. Full height photograph of wing wall following removal of ACM panels and rail substructure.

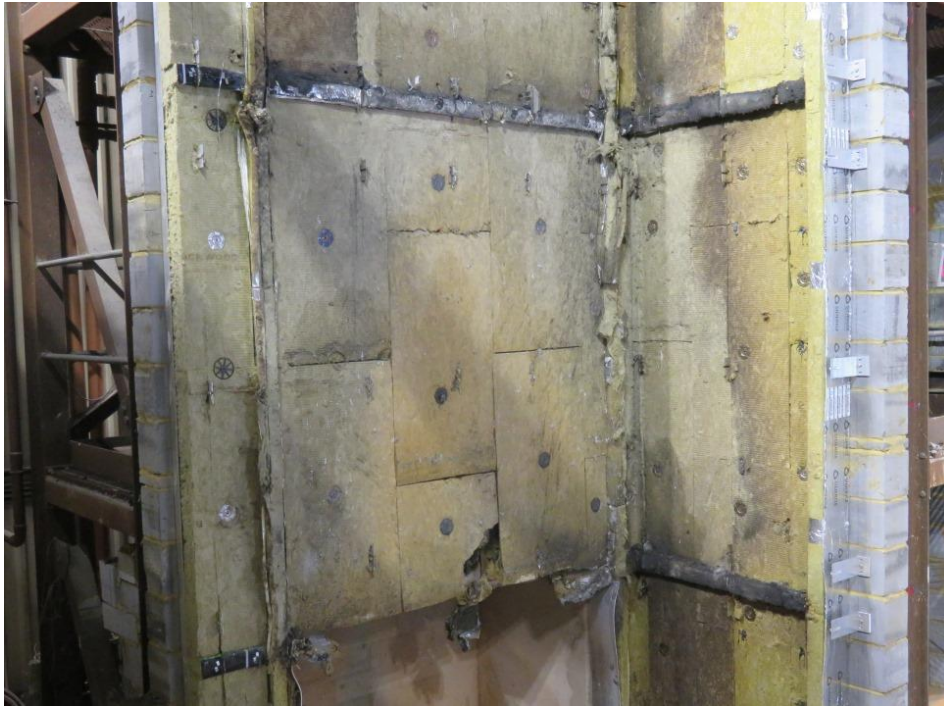
Figure 33. Cladding system beneath ACM panels and rail substructure between the first and second horizontal cavity barrier (approximately 0-2400mm above combustion chamber).

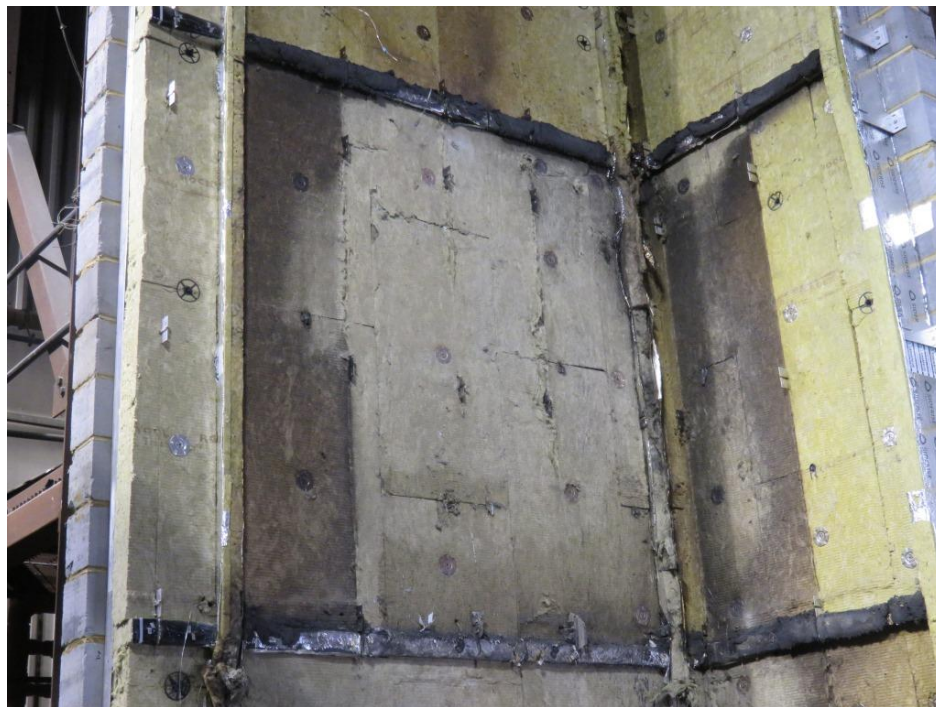
Figure 34. Cladding system beneath ACM panels between the second and third horizontal cavity barrier (approximately 2400-4700mm above combustion chamber).
