Seismic Testing of Fire Stopping Products: Can we build to withstand an earthquake?

SEISMIC TESTING OF FIRE STOPPING PRODUCTS

By Rakic, J. , McDonald, S. , Henry, J. & Todd, C.

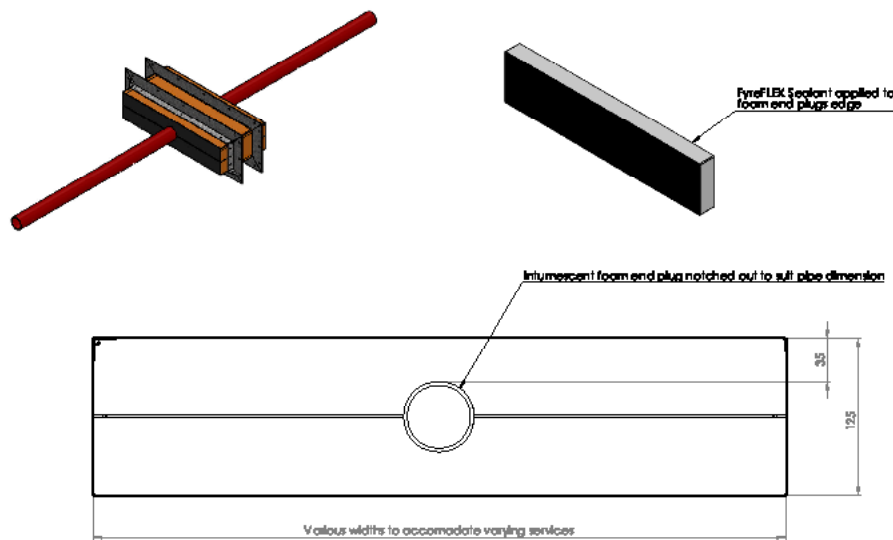
Results from the Preliminary Seismic Trials

- 20mm right and 20mm left (overall displacement of 40mm) – looked fine
- 20mm up and down – again looked fine
- 20mm out of plane – again looked fine

Repeat at 30 and then 50mm – No significant change except in up and down as pipe was hitting on top and bottom of SuperSTOPPER body as the internal dimension of model tested on has 125mm clearance and with a pipe of 50mm this only allow for 30mm nominal movement before interference. This caused some minor cracking or tearing of the foam.
