Fire-resistance test on services penetrating a plasterboard wall system

Test Report

Author: Peter Gordon
Report number: FSP 2230
Date: 8 November 2021
Client: Trafalgar Group Pty Ltd

Sponsored Investigation No. FSP 2230

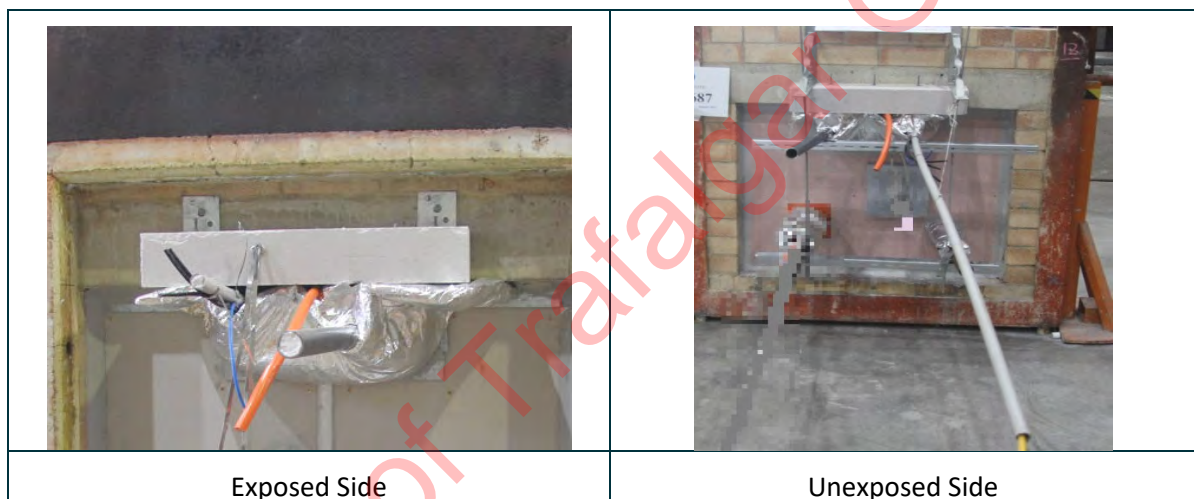
The FyreBOX 350 comprised a 350-mm wide x 125-mm high x 300-mm deep 'Slab Mounted' variant, constructed with a separate top plate that utilises a clip-together design to mate with the U-shaped lower section. This allows the top plate to be installed prior to wall construction. The FyreBOX top plate was mounted using 3 x M6 threaded bolts on both sides through pre-formed holes in the top plate, screwed into an AAC block which was used as a lintel extension to represent a concrete floor slab. Two top minor mounting plates (nominally 138-mm x 350-mm) were spot welded at each end on of the FyreBOX top plate with a 350-mm long x 50-mm wide x 1.5-mm thick GeeWhiz intumescent strip centrally located between the minor plates and sandwiched directly under the concrete lintel.

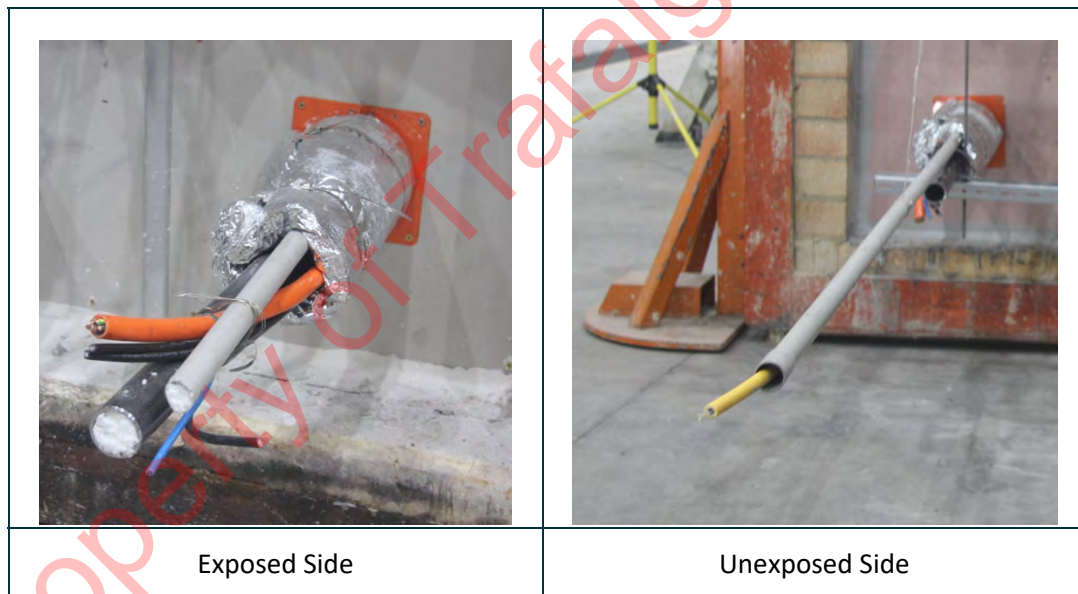
The cables, conduit and steel pipe were fixed together with stainless-steel cable ties at 200-mm centres and penetrated the wall through a 110-mm diameter opening in the plasterboard. All the cables and the steel pipe projected horizontally 500-mm away from the unexposed face and 500-mm into the furnace chamber. The electrical conduit projected horizontally 2000-mm away from the unexposed face and 500-mm into the furnace chamber. Both the steel pipe and the NBN conduit were left open on the unexposed side and plugged with ceramic fibre (Superwool) on the exposed face.

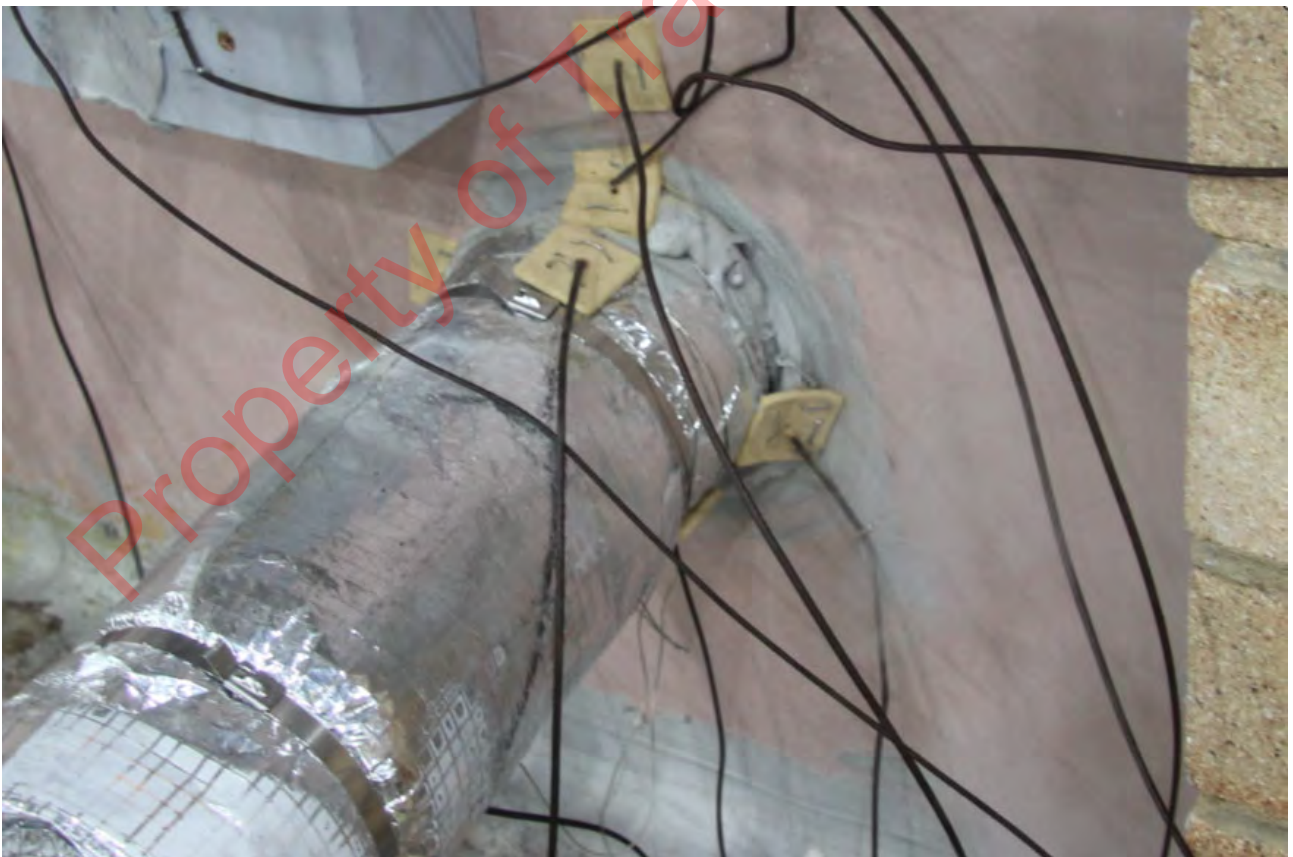
PHOTOGRAPH 6 – SPECIMEN 4 AT 58 MINUTES INTO THE TEST

34 minutes	- The joint in the Maxilite panels of Specimen 2 has begun to split.
55 minutes	- The level of smoke from the Twrap and services of Specimen 3 has reduced.
58 minutes	- The sealant around the base of Specimen 4 has bubbled.
70 minutes	- <u>Insulation failure of Specimen 3</u> - maximum temperature rise of 180K is exceeded on the FyreBOX flange (top right corner) at the base the specimen.
76 minutes	- Smoke has resumed fluing from the end of the conduit of Specimen 1. Sealant at the head of the wall adjacent to the Twrap of Specimen has begun to swell.
86 minutes	- The plasterboard wall behind the FyreBOX flange of Specimen 3 has begun to char.
90 minutes	- The plasterboard wall around the base of Specimen 2 has begun to char.
93 minutes	- The sealant around the cables at the at the base of Specimen 2 has begun to swell.
95 minutes	- The plasterboard wall around the base of Specimen 3 has begun to char.

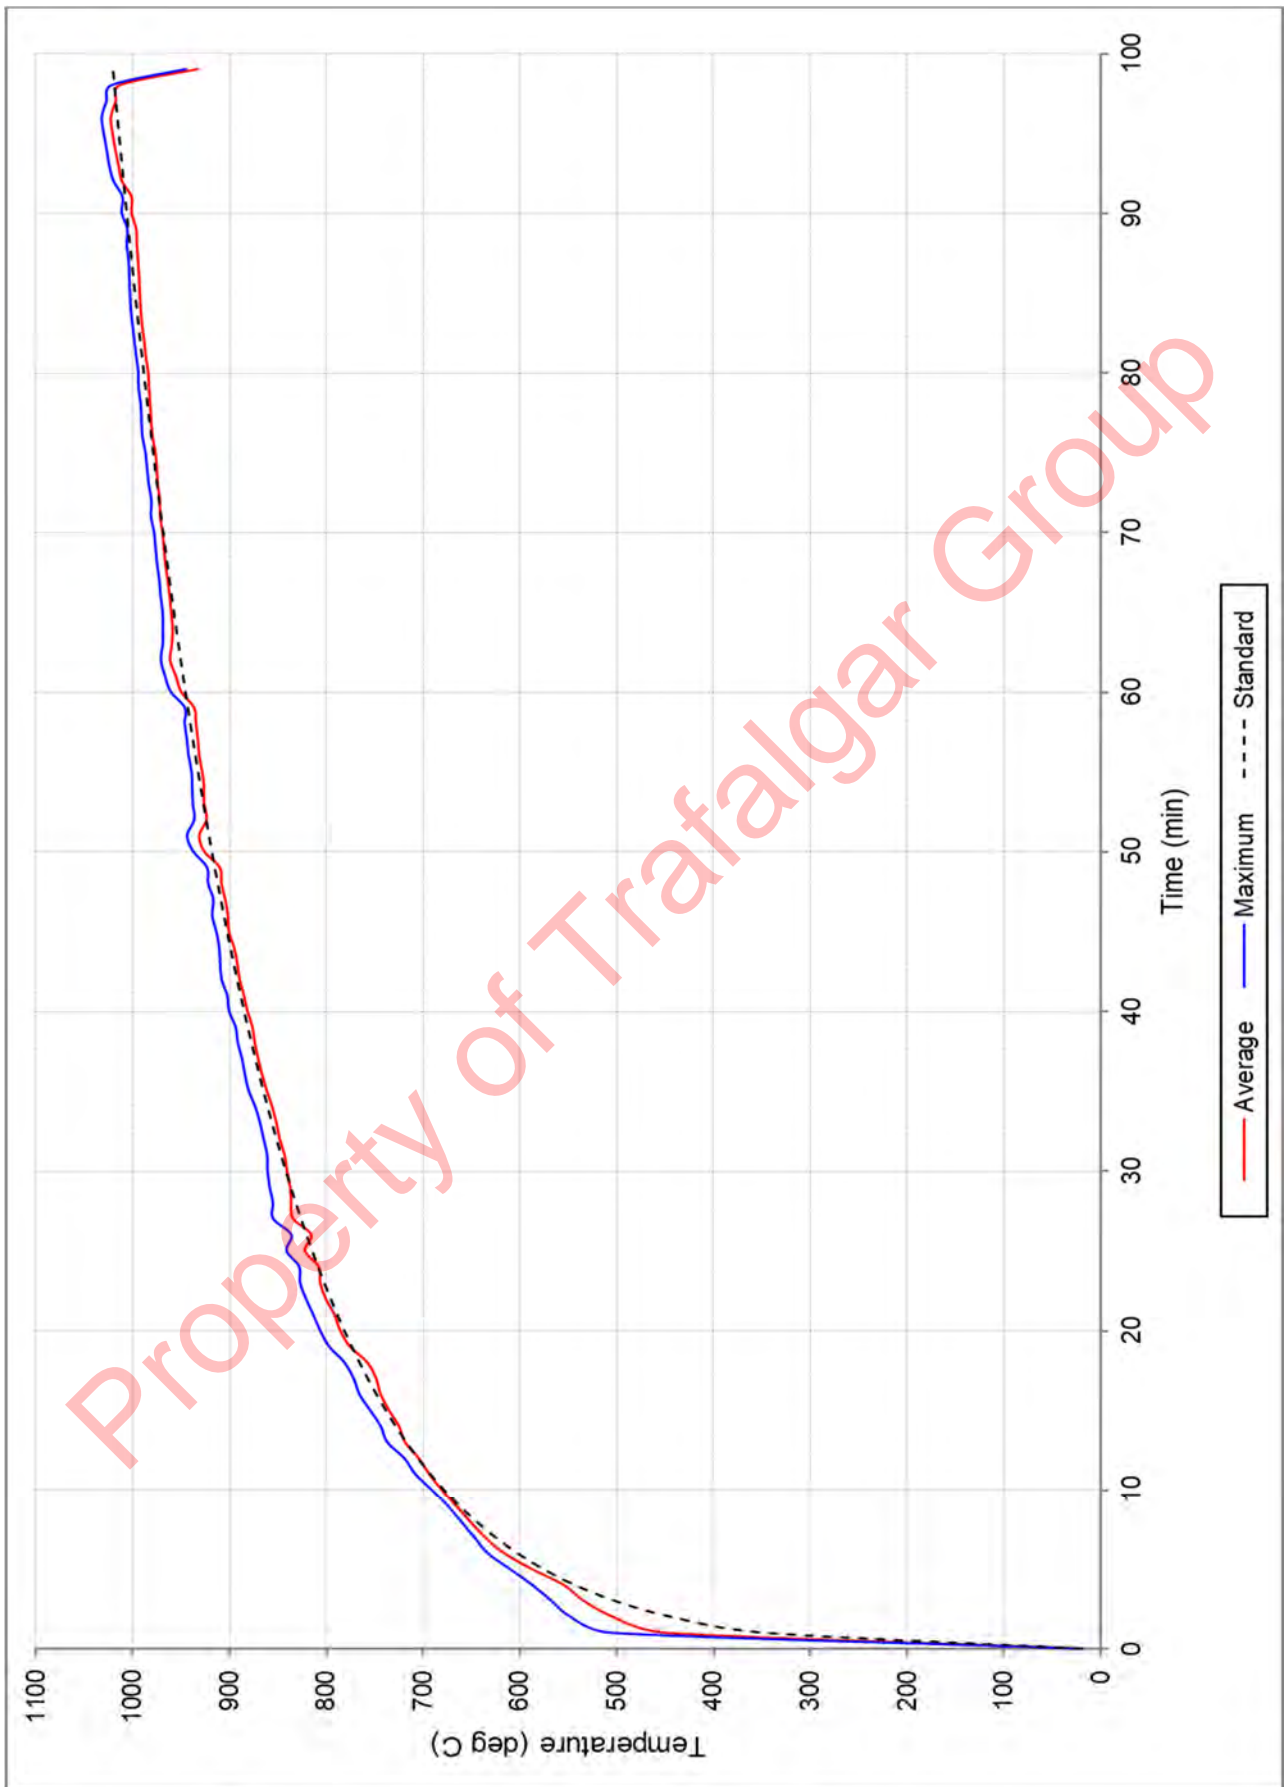
FIGURE 1 – FURNACE TEMPERATURE

Figure 1 shows the standard curves of temperature versus time for heating the furnace chamber and the actual curves of average and maximum temperature versus time recorded during the heating period.

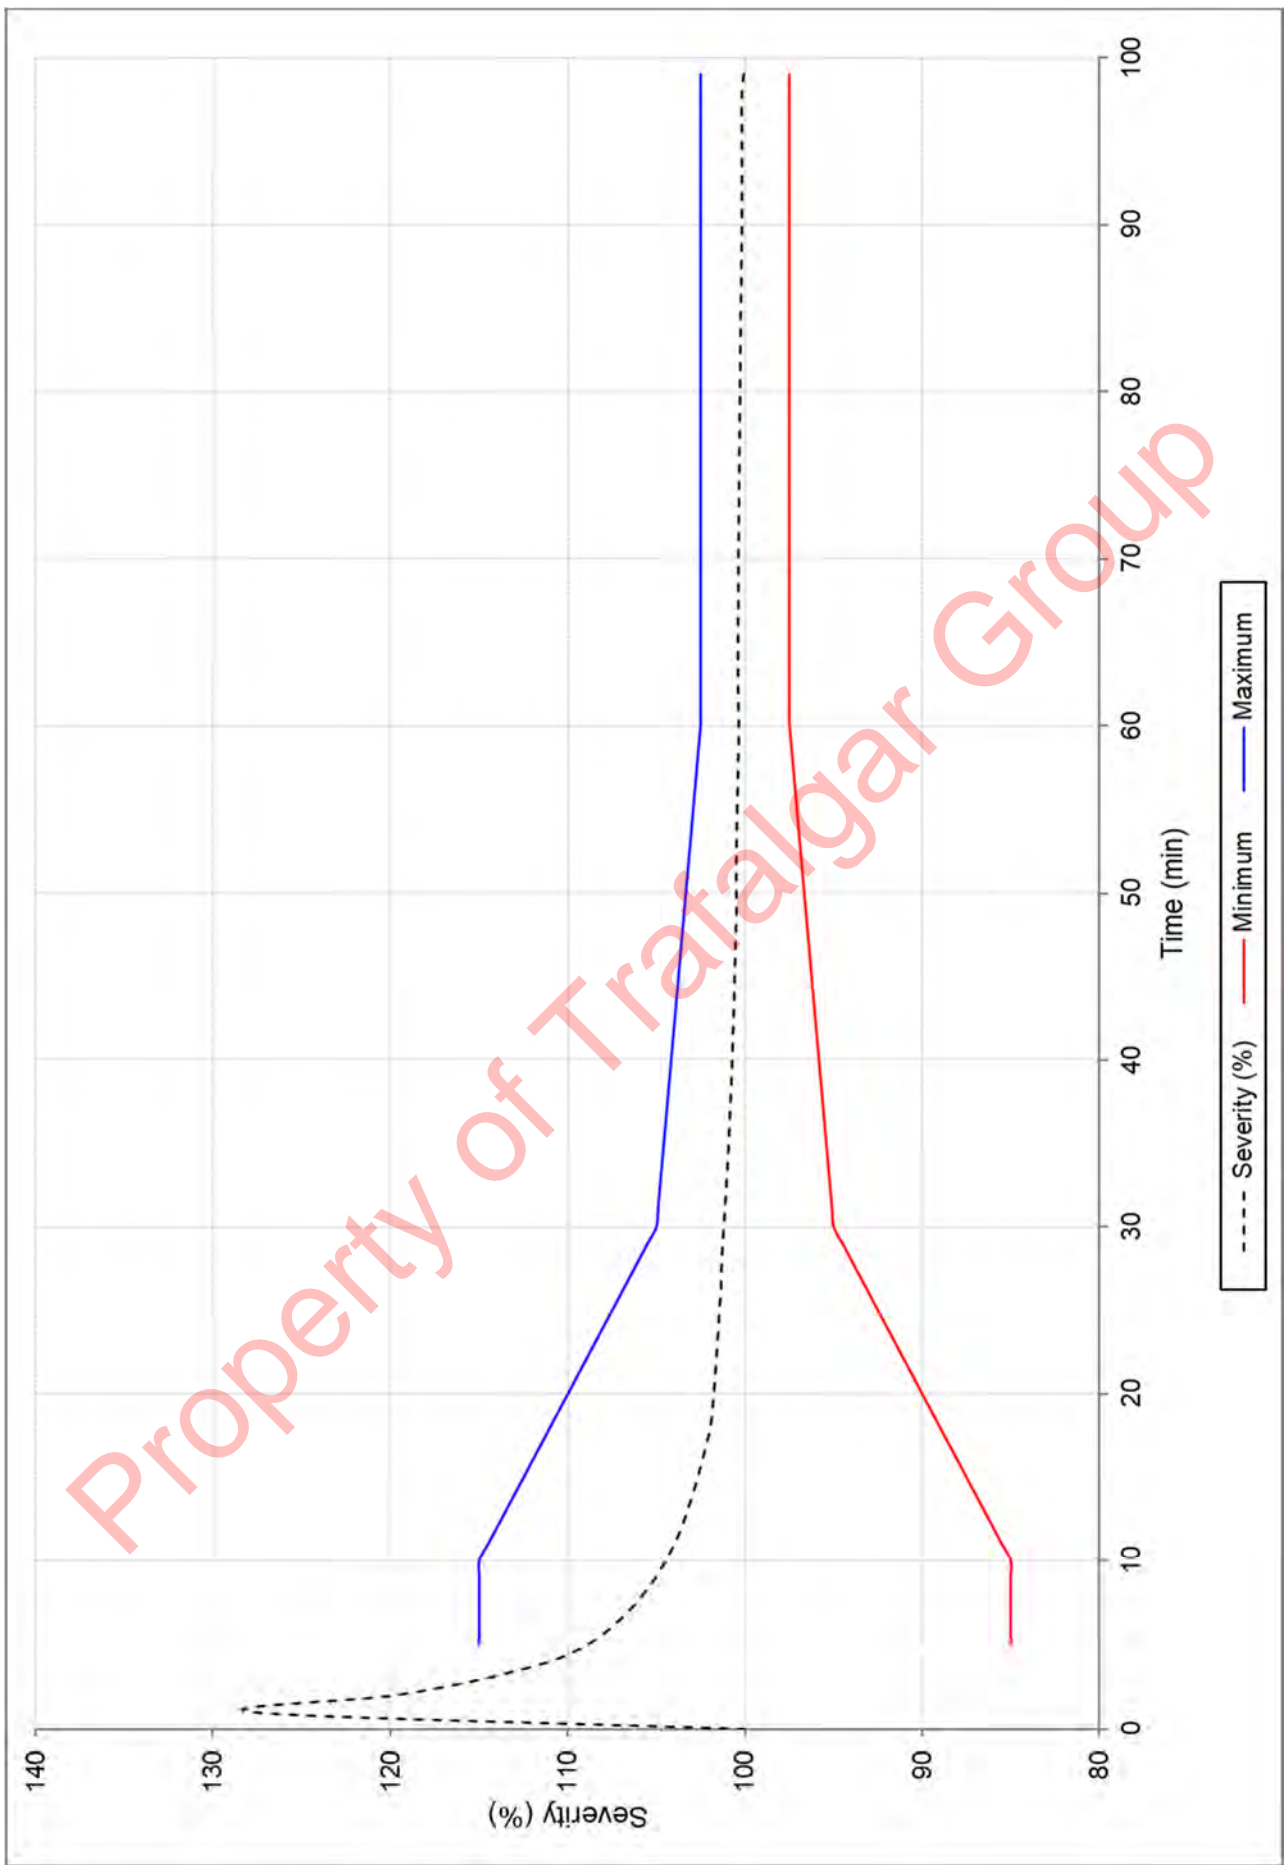
FIGURE 2 – FURNACE SEVERITY

Figure 2 shows the curve of furnace severity versus time during the heating period.

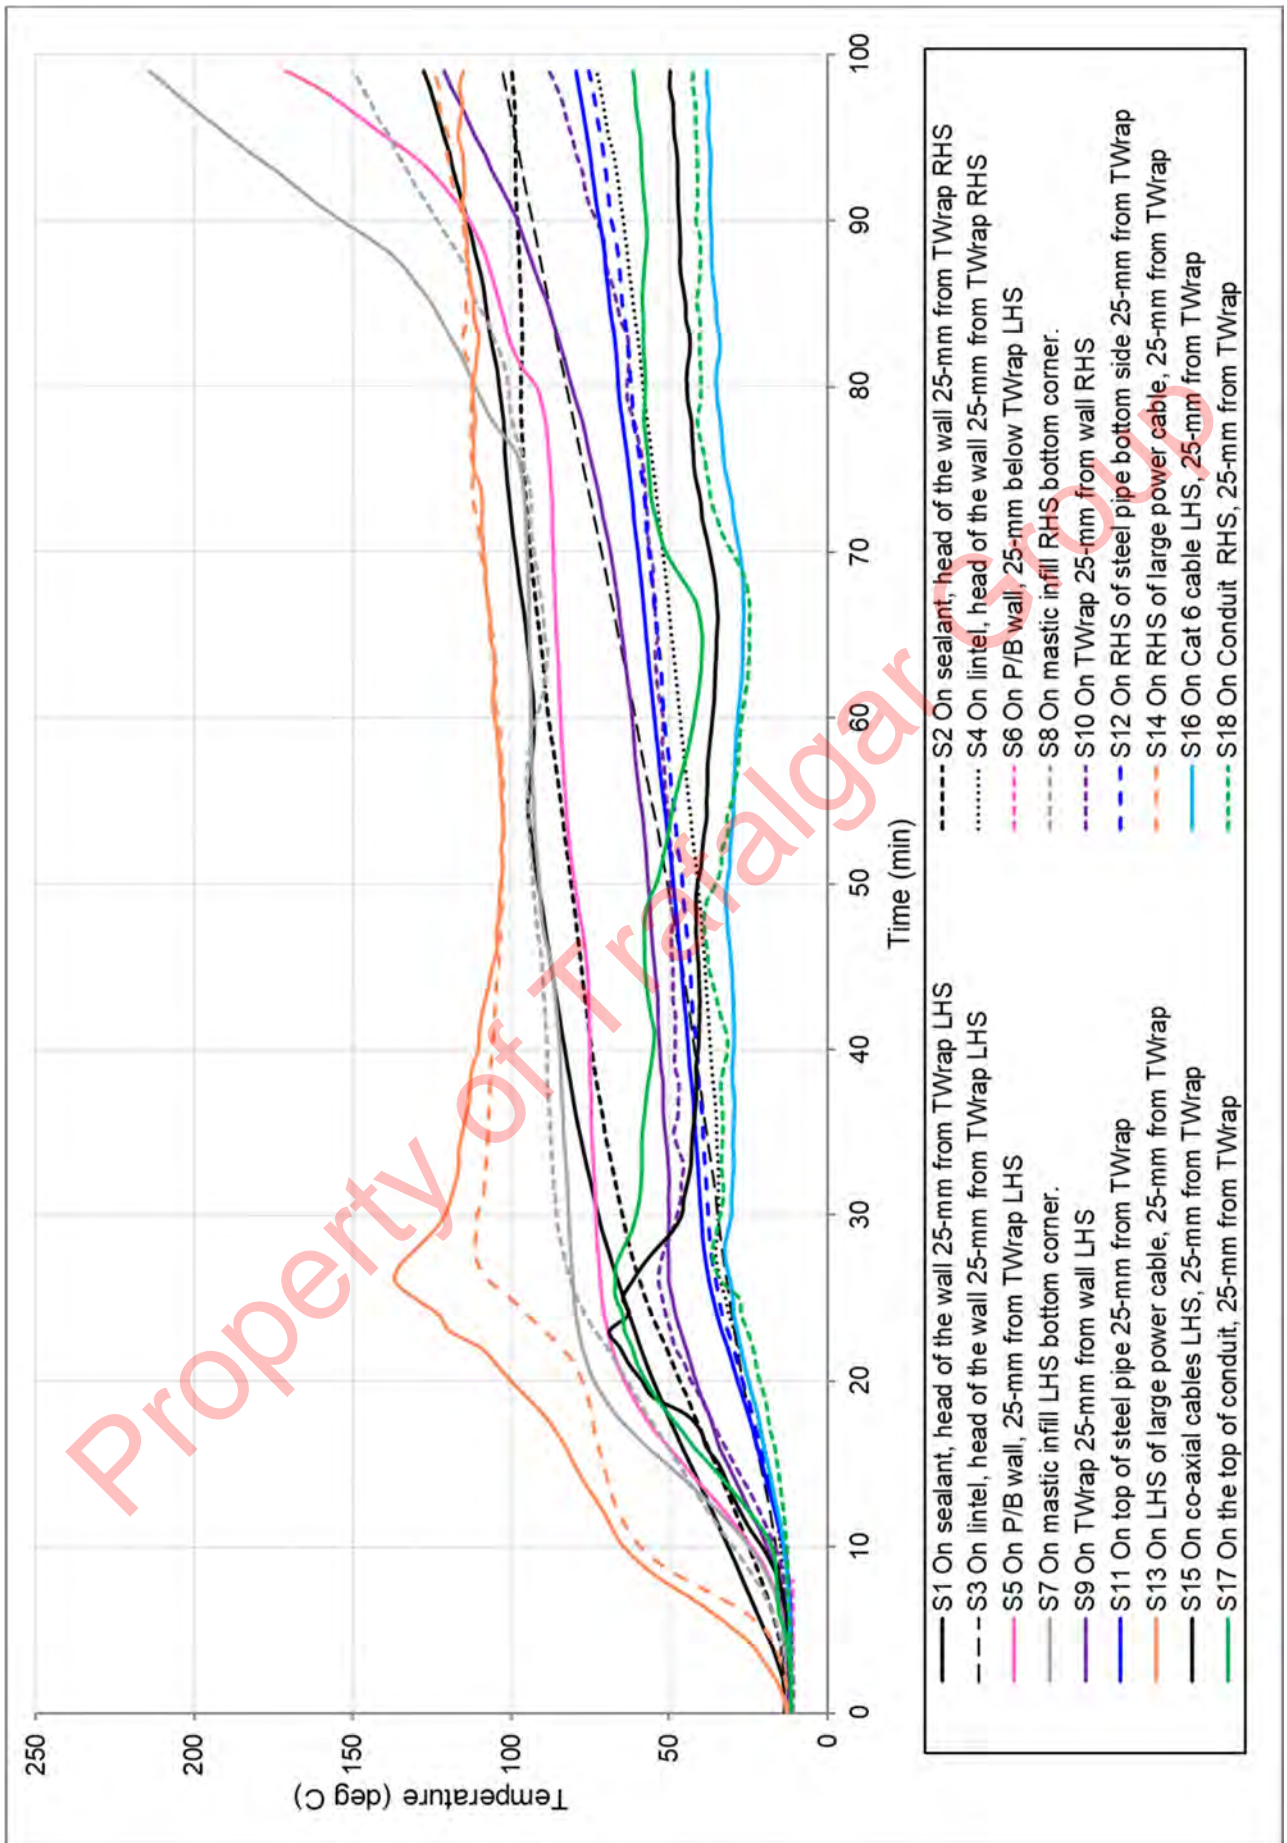
FIGURE 4 – SPECIMEN TEMPERATURE – ASSOCIATED WITH SPECIMEN 1

96 minutes	- <u>Insulation failure of Specimen 1</u> - maximum temperature rise of 180K is exceeded on the Plasterboard, 25-mm below the concrete slab.
98 minutes	- Test terminated.

Figure 4 shows the curve of temperature versus time associated with Specimen 1.

Structural adequacy	-	not applicable
Integrity	-	no failure at 98 minutes
Insulation	-	96 minutes

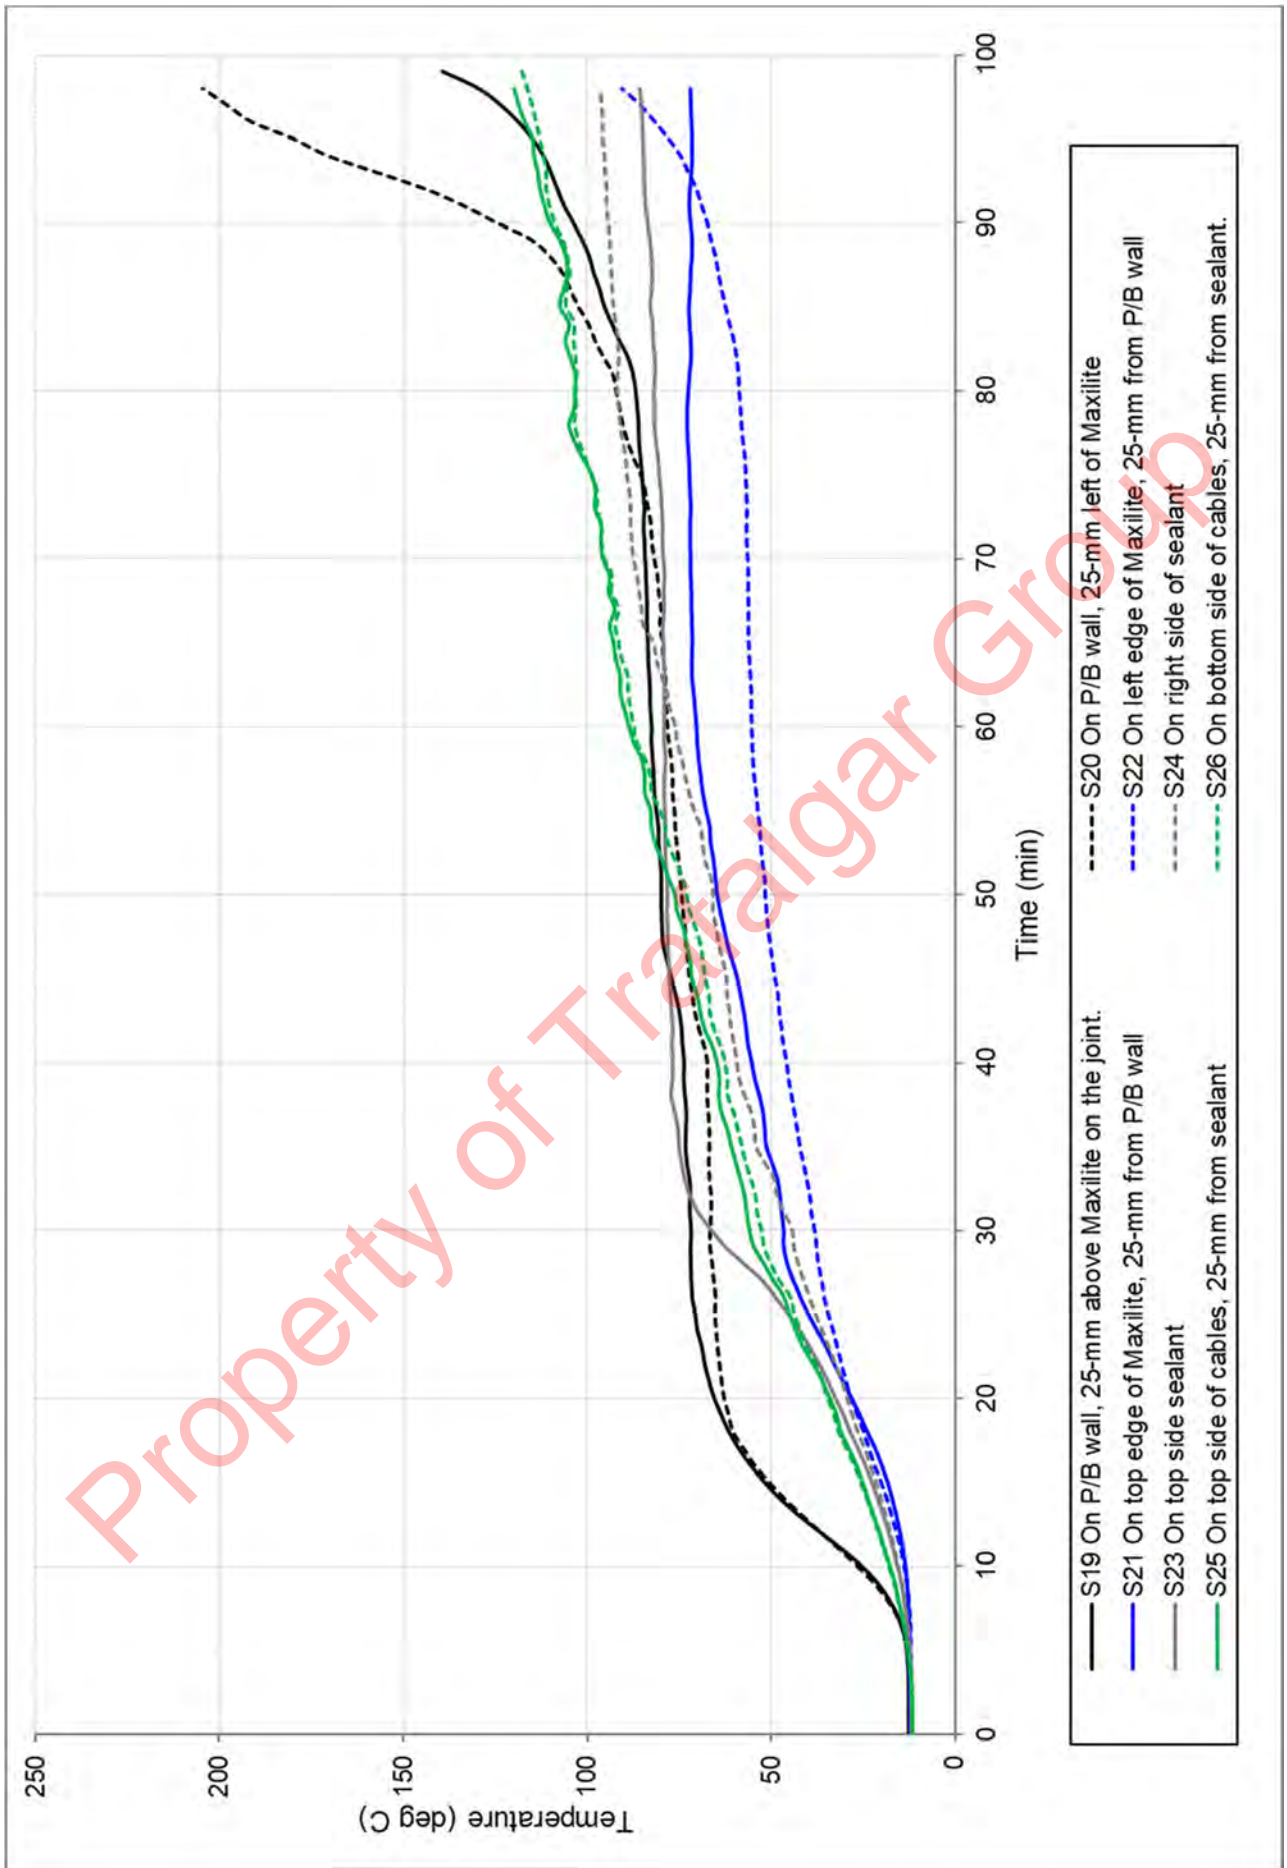
FIGURE 5 – SPECIMEN TEMPERATURE – ASSOCIATED WITH SPECIMEN 2

Figure 5 shows the curve of temperature versus time associated with Specimen 2.

Structural adequacy	-	not applicable
Integrity	-	no failure at 98 minutes
Insulation	-	no failure at 98 minutes

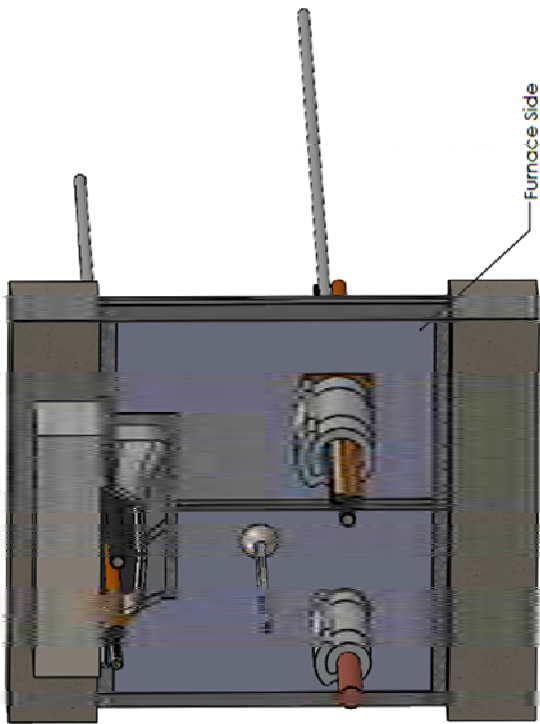
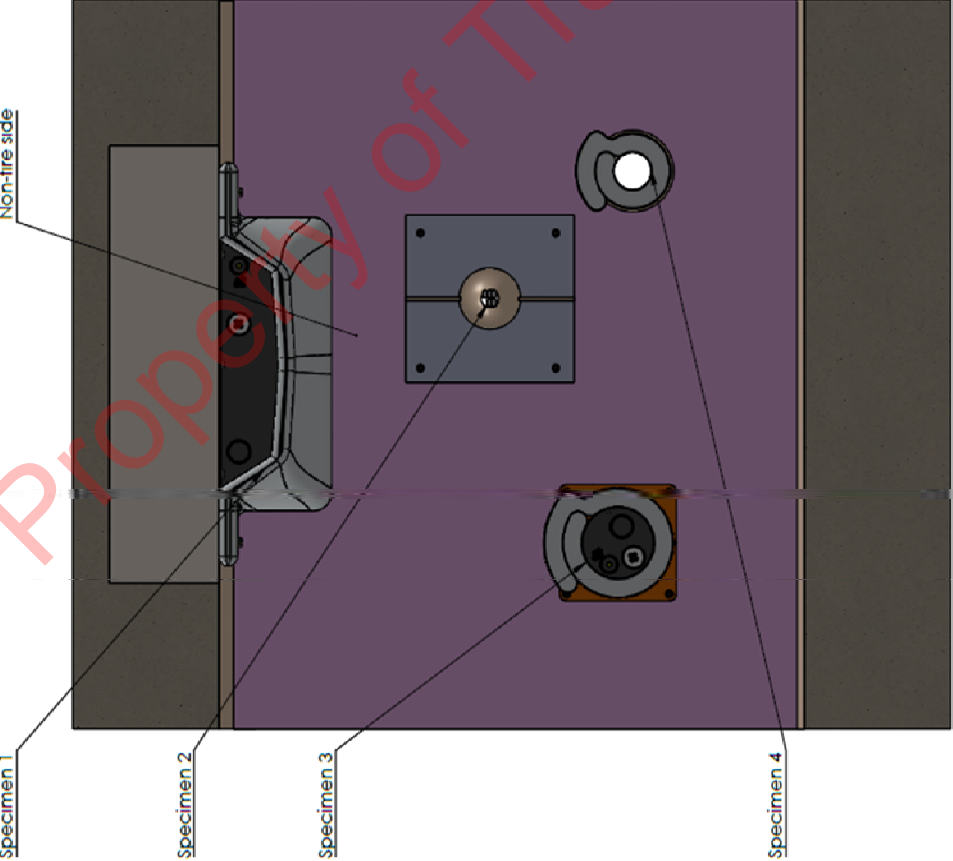
DRAWING TITLED 'TEST OVERVIEW', DATED 27 SEPTEMBER 2021, BY TRAFALGAR GROUP PTY LTD

Specimen	Opening Size	Fire Stopping	Services
Specimen 1	380x 140	350 x 125 FireBOX Slab-Mount, FireFLEX insulant and Twrap	3xRG6 Quadshield Co-axial cable, 1xCAT6 cable, 1x 16mm ² 4C+E power cable, 1x25mm UPVC Conduit and 1x 32mm steel pipe
Specimen 2	30	60mm FireBOARD Makliffe and FireFLEX sealant	5 x 1.5mm ² ZC+E TFS Cable bundle
Specimen 3	110	100mm Round FireBOX and Twrap	3xRG6 Quadshield Co-axial cable, 1xCAT6 cable, 1x 16mm ² 4C+E power cable, 1x25mm UPVC Conduit and 1x 32mm steel pipe
Specimen 4	76	FireFLEX sealant and Twrap	DN50 Copper Pipe
