Fire resistance test report

Test standard: Sections 2 and 3 of AS 1530.4:2014

Test sponsor: Trafalgar Group Pty Ltd

Product: Trafalgar bushfire wall system

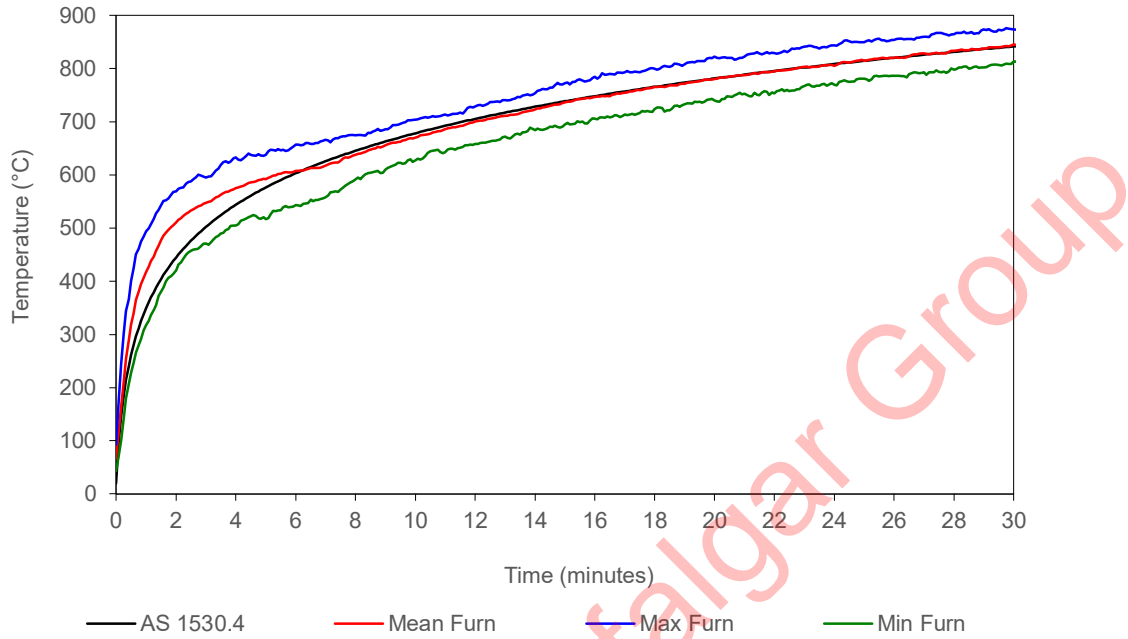
Figure 7 Furnace thermocouple temperature vs time

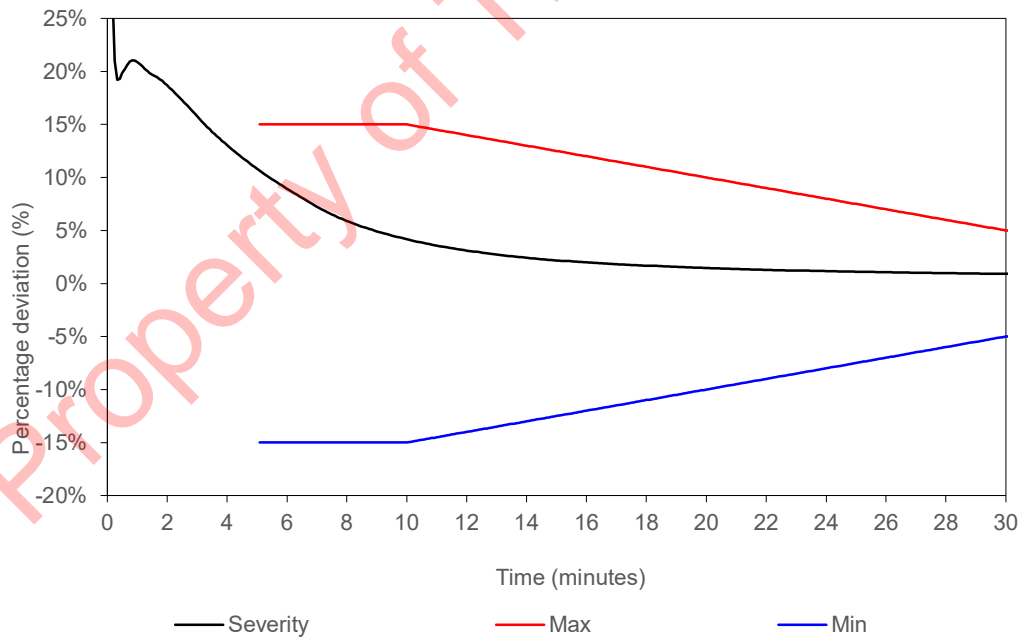
Figure 8 Percentage deviation of exposure severity vs time

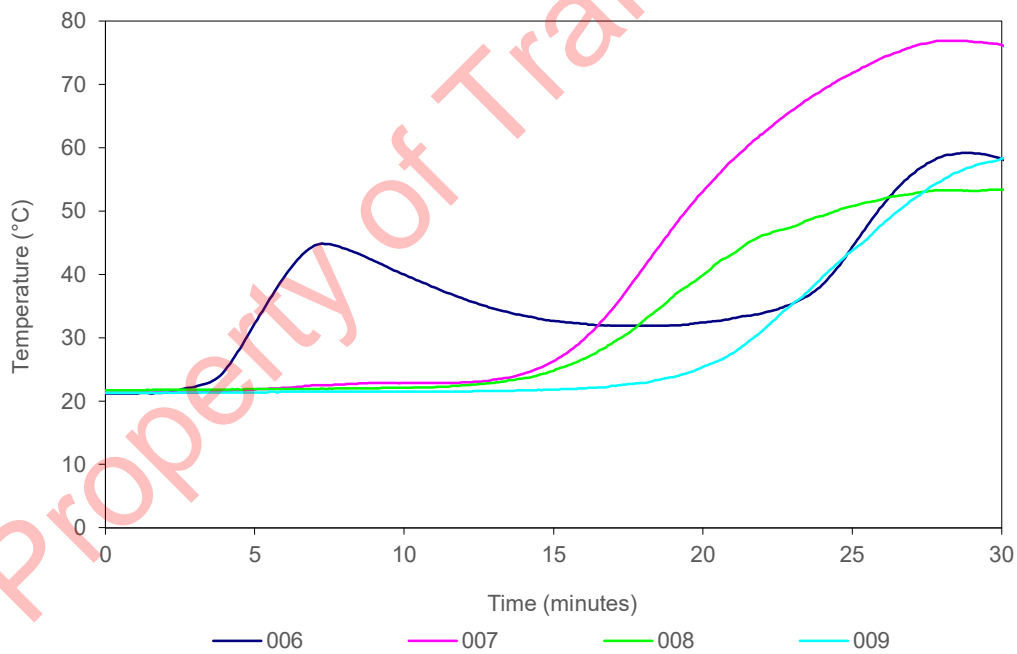
Figure 11 Other surface – temperature vs time

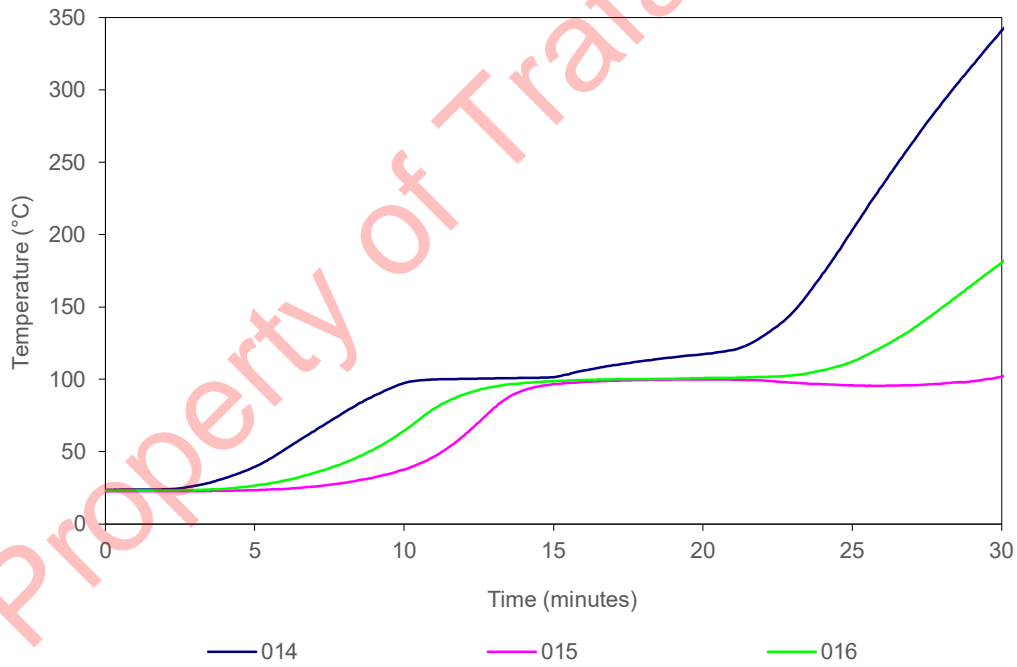
Figure 13 Steel nogging – temperature vs time

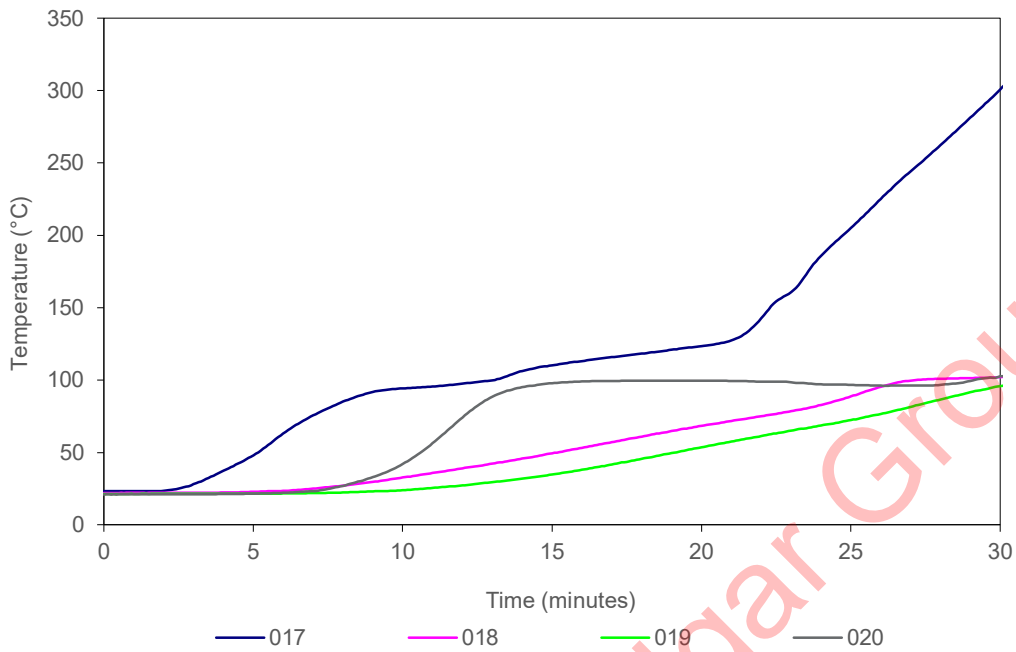
Figure 14 Timber noggings – temperature vs time

Note: TC021 TC malfunction throughout the whole test period.

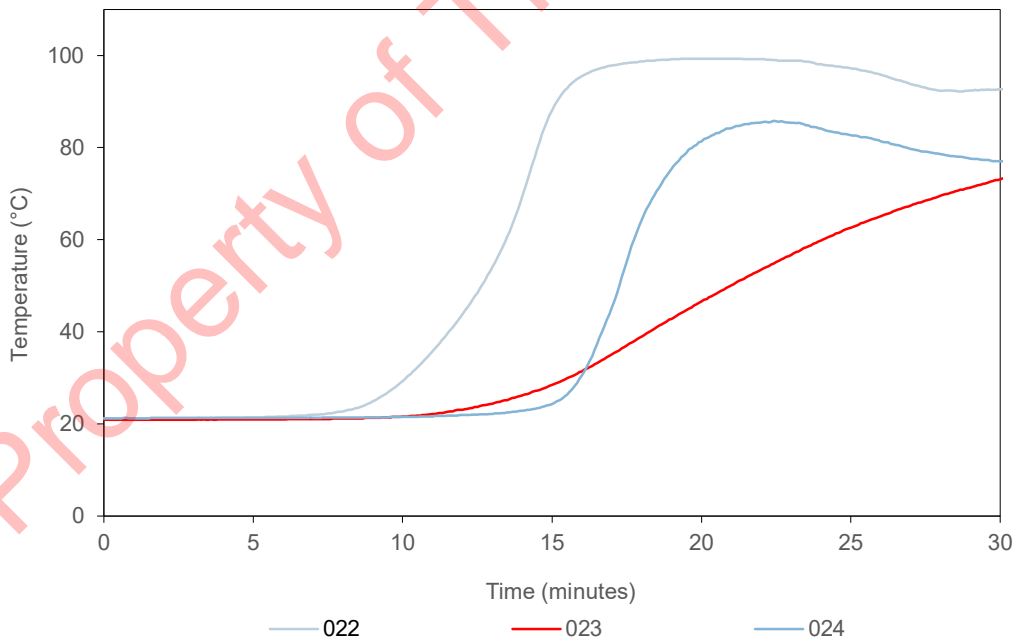
Figure 15 Timber noggings – temperature vs time

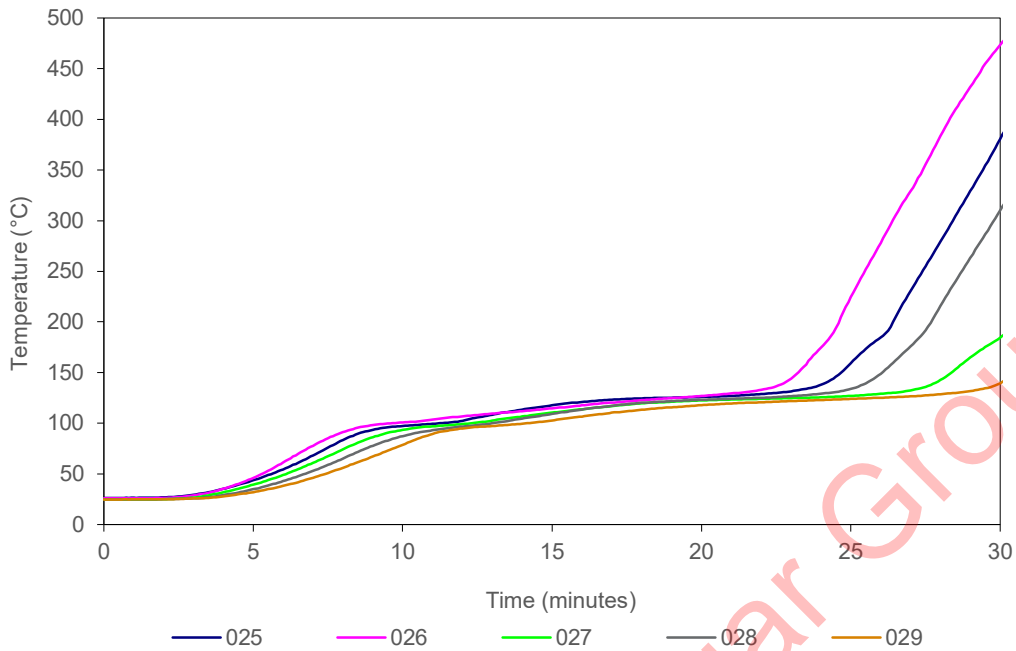
Figure 16 Internal (unexposed side of BoardeX cladding) – temperature vs time

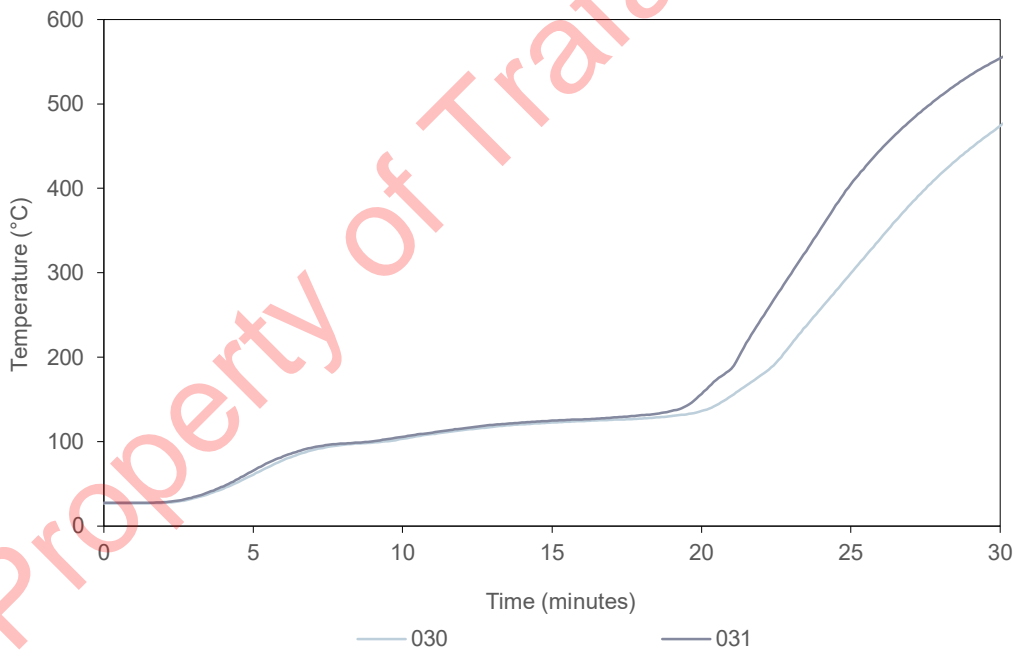
Figure 17 Internal (unexposed side of BoardeX cladding) – temperature vs time

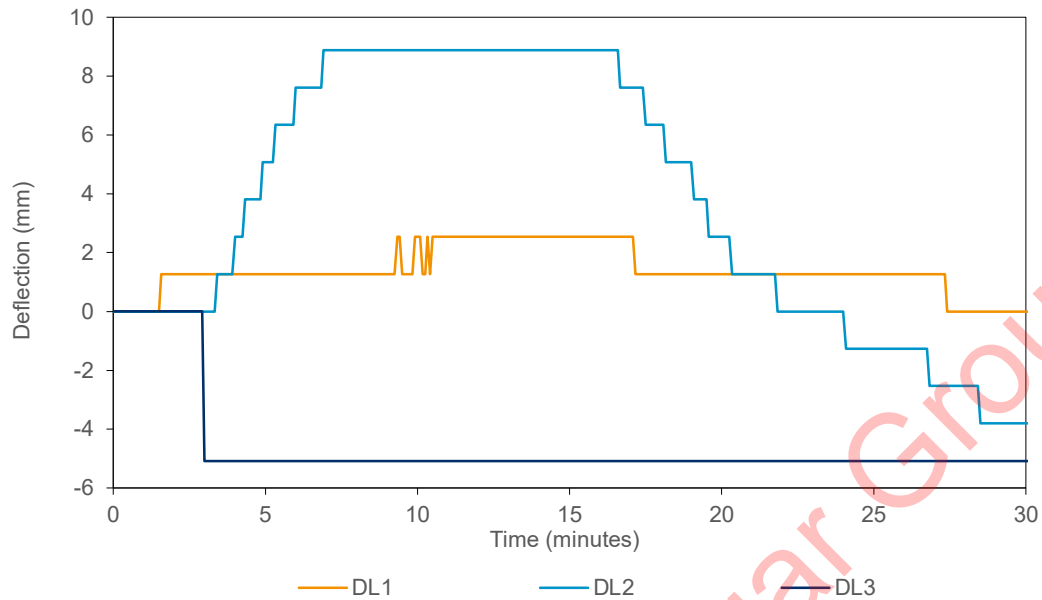
- Positive measurements show movement of the test specimen towards the furnace.
- Negative measurements show movement of the test specimen away from the furnace.

Figure 22 Deflection of test specimen vs time – horizontal deflection

Part of specimen	Ref	Description
Horizontal	DL1	50 mm from the fixed south edge of the plasterboard mid-height.
	DL2	Centre of the plasterboard at mid-height.
	DL3	50 mm from the free north edge of the plasterboard mid-height.

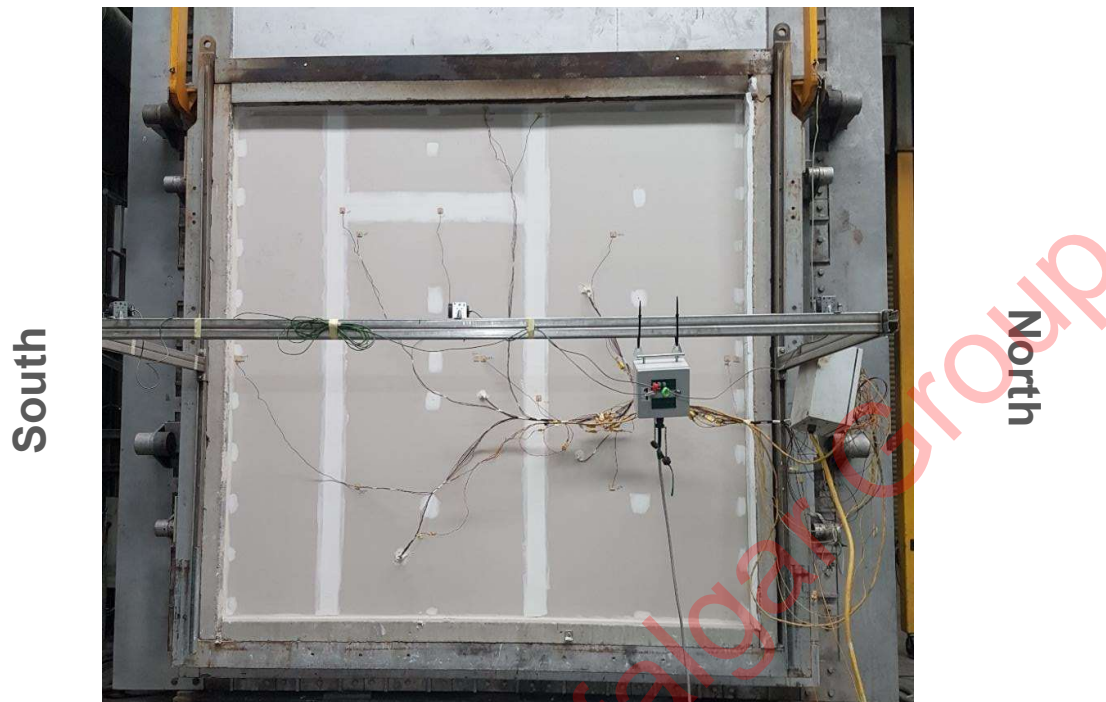
Figure 23 Unexposed face of the specimen before the start of the test

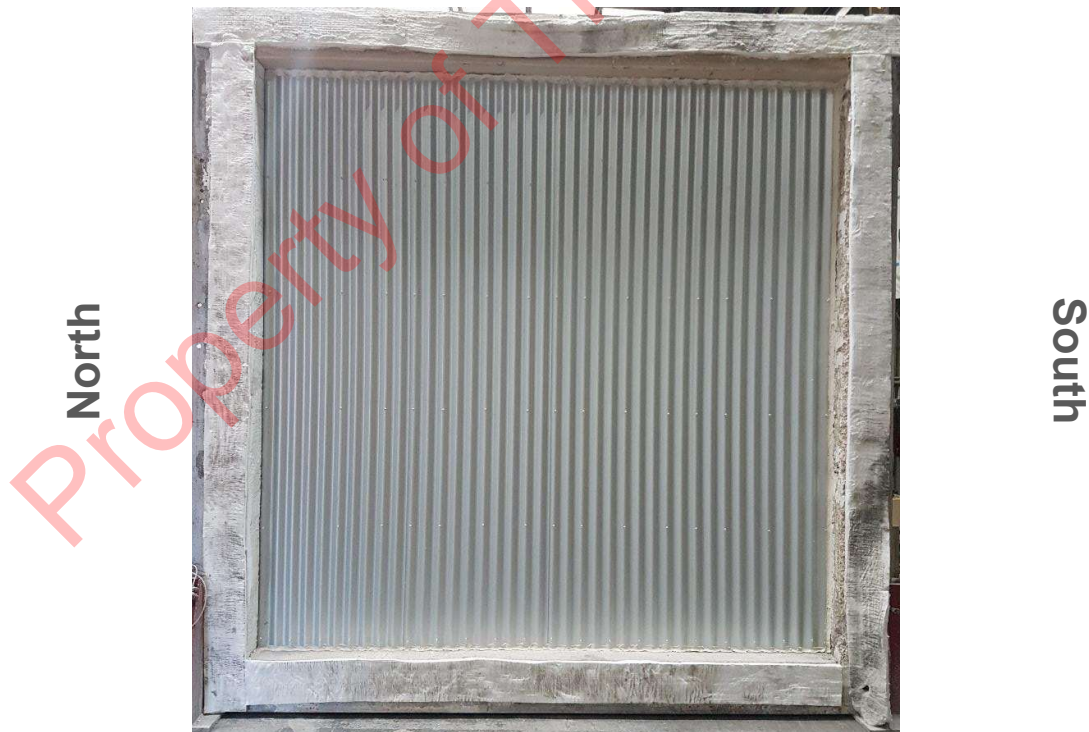
Figure 24 Exposed face of the specimen before the start of the test

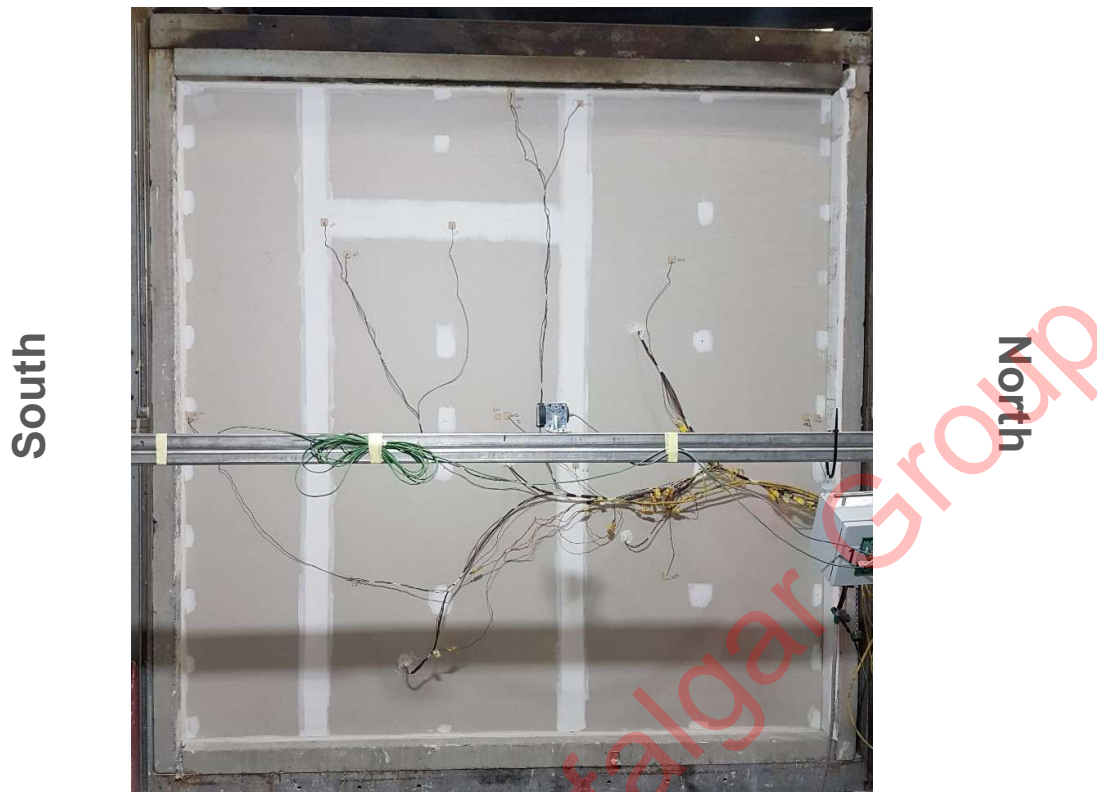
Figure 25 Unexposed face of the specimen at the end of the test

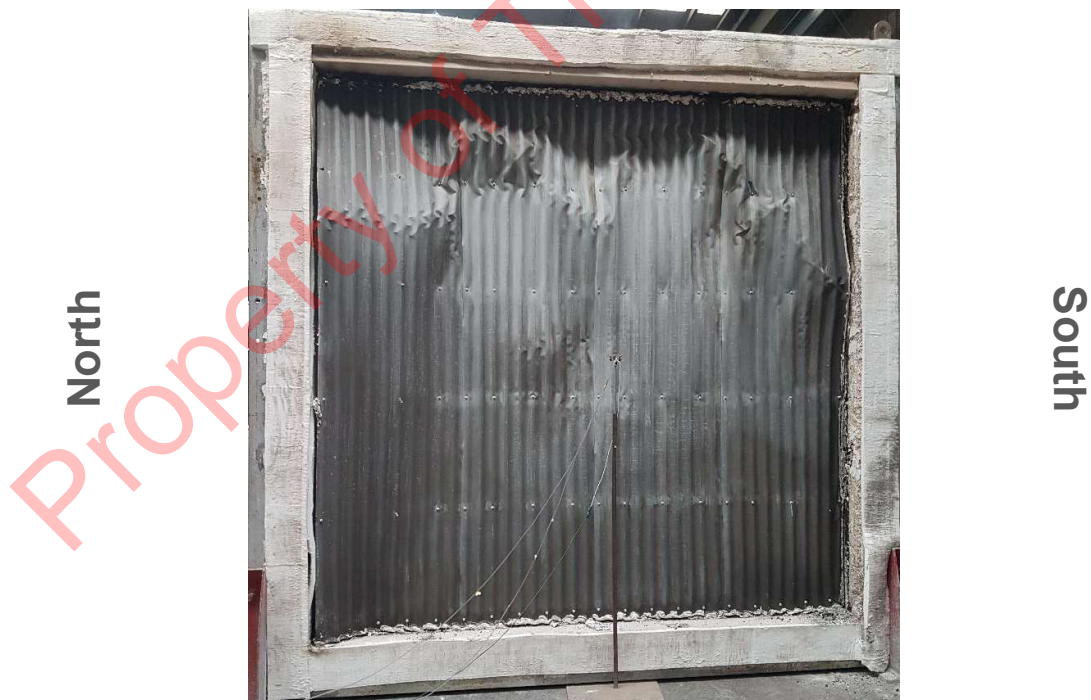
Figure 26 Exposed face of the specimen at the end of the test
