Foreword to the AS1530.4-2014 test report for the BladeRUNNER system

Fire-resistance test on services penetrating a concrete slab

Test Report

Author: Shaw Tran
Report number: FSP 2317
Date: 14 November 2022

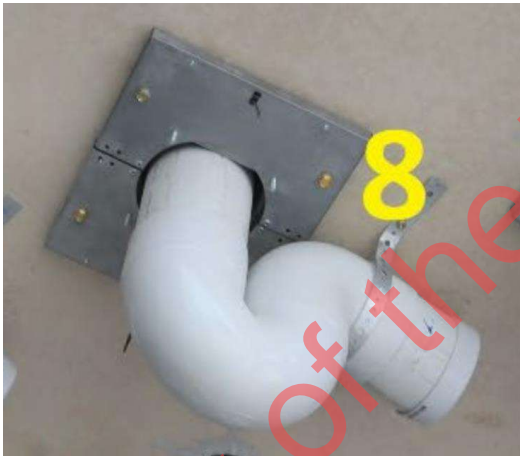
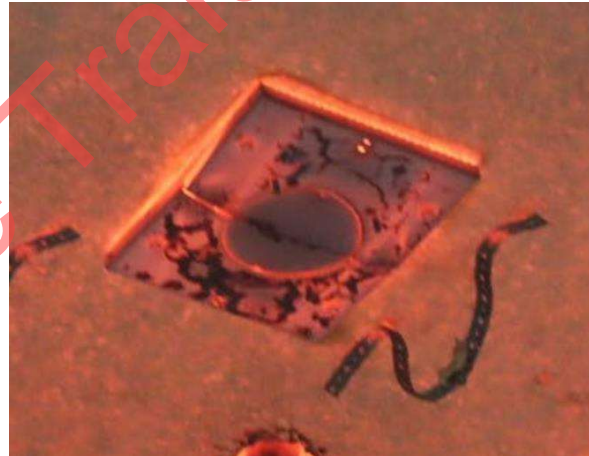
Images of specimen 8 from fire test FSP2317 – BladeRUNNER before and after the 4 hour fire test

The BladeRUNNER was tested at the CSIRO on the 14th of November and the test report is attached below. There were numerous specimens tested including various prototypes of the retro fit floor waste collar. **Specimen 8 was the penetration system that used the current BladeRUNNER design.**

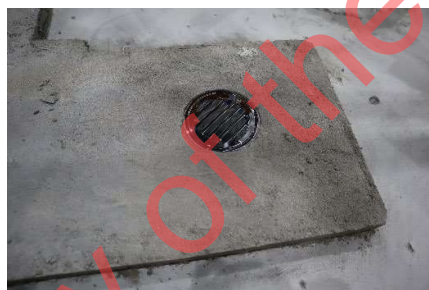
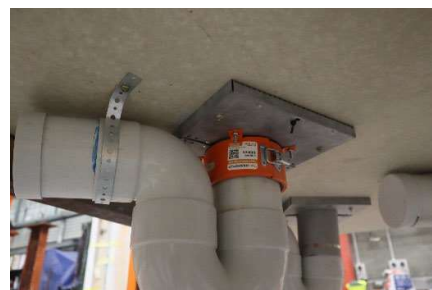
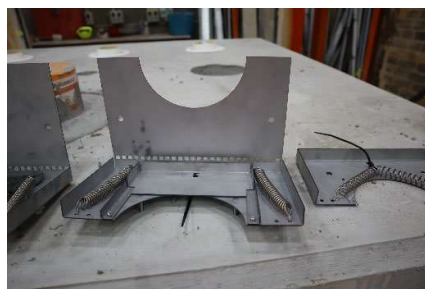
Specimen 4 – A Trafalgar ‘Springbox – Blade with Fyrecollar’ protecting a 100-mm diameter PVC pipe with floor waste incorporating a P trap penetrating a 121-mm opening in the slab

The Trafalgar Springbox – Blade with FyreCOLLAR was constructed from 1.1-mm mild steel plate and consisted of two symmetrical halves. Each half contained a baseplate measuring 140-mm wide x 120-mm long x 20-mm high. The top side of the baseplate contained a blade measuring 154-mm wide x 69-mm long x 15-mm high flange. The blade was held in place with a 12-mm wide x 10-mm high x 137-mm long angles which were secured to the baseplate at the front by two 4-mm steel rivets and at the rear with two M5 x 20-mm press studs. Each blade contained a tensioned spring secured to the baseplate with the blade being pulled back to the rear and held into place with 3.6-mm wide x 1.4-mm thick plastic cable ties. Details are shown in drawing “Springbox blade with FyreCOLLAR” dated 18/10/22, by Trafalgar Fire.

The penetrating service comprised an Iplex Pipelines DWV uPVC pipe with a 110-mm outside diameter and a wall thickness of 3-mm. The pipe penetrated the concrete slab through a 121-mm opening. On the exposed side of the slab, the pipe was fitted with two halves of the Trafalgar Springbox and secured to the concrete slab using M6 x 50-mm masonry anchors. As shown in drawing “CP34 V3” dated 17/10/2022, by Trafalgar Fire.

On the exposed side of the slab, a PVC P-trap was connected to the penetrating pipe with a coupling. The P-trap was plugged with a PVC end cap and supported on the exposed face with 30-mm wide steel strapping fixed to the concrete slab using two M6 x 50-mm masonry anchors. The trap was charged with 1.5-L of water prior to testing. On the unexposed face of the slab a floor waste system was fitted with a polypropylene puddle flange, an acrylonitrile-butadiene-styrene base and a chrome plated brass grate. A 30-mm thick sand and cement screed was laid on top of the concrete slab and finished flush with the grate.

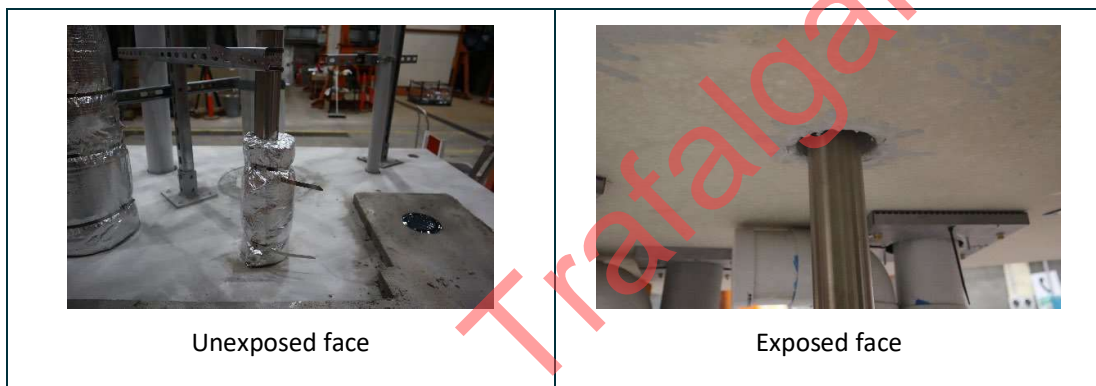
Specimen 5 – A 60-mm diameter stainless steel pipe lagged with Twrap penetrating an 80-mm opening in the slab

The penetrating service comprised a stainless-steel pipe with a 60-mm outside diameter and a wall thickness of 1.5-mm which penetrated the concrete slab through a 80-mm opening. The pipe was installed off centre with a resulting annular gap of 8-mm to 18-mm which was backfilled with a bead of Trafalgar FyreFLEX sealant to a depth of 60-mm controlled by a PE backing rod and finished with a 20-mm x 30-mm fillet, as shown in drawing “CP34 V3” dated 17/10/2022, by Trafalgar Fire.

On the unexposed side only, a single layer of 300-mm wide x 25-mm thick TWrap (128-kg/m³) was cut to size and wrapped around the stainless-steel pipe with a 50-mm overlap and secured with two 4.6-mm wide stainless steel cable ties located at 50-mm from each end. Any cut edges in the Twrap were sealed with aluminium reinforced tape.

The pipe projected vertically, 500-mm away from the unexposed face of the slab and approximately 500-mm into the furnace chamber. The pipe was supported at nominally 450-mm from the unexposed face of the concrete slab by a support clamp. The pipe was open at the unexposed end and closed with 100-mm of ceramic fibre plug on the exposed end.

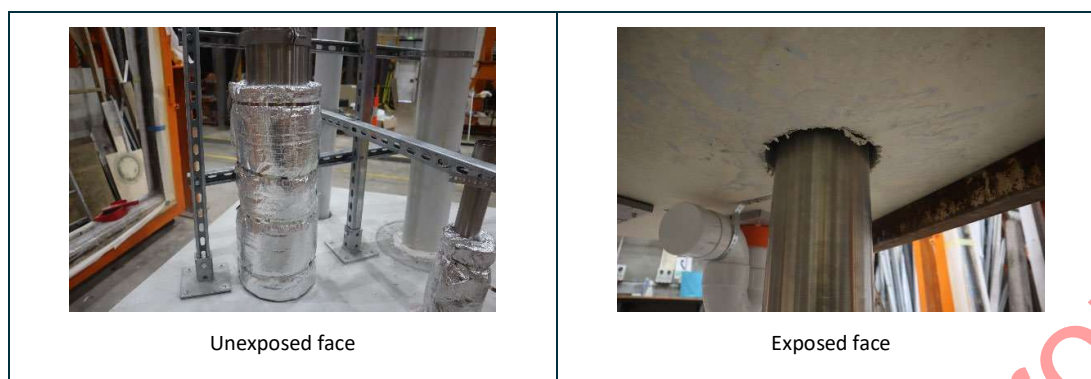
Specimen 6 – A 170-mm diameter stainless steel pipe lagged with Twrap penetrating a 200-mm opening in the slab

The penetrating service comprised a stainless-steel pipe with a 170-mm outside diameter and a wall thickness of 1.5-mm, which penetrated the concrete slab through a 200-mm opening. The pipe was installed off centre with a resulting annular gap of 5-mm to 25-mm and was backfilled with a bead of Trafalgar FyreFLEX sealant to a depth of 60-mm controlled by a PE backing rod and finished with a 30-mm x 30-mm fillet, as shown in drawing “CP34 V3” dated 17/10/2022, by Trafalgar Fire.

On the unexposed side only, a single layer of 300-mm wide x 25-mm thick TWrap (128-kg/m³) was cut to size and wrapped around the stainless-steel pipe with a 50-mm overlap. Another layer of 300-mm TWrap was cut to size and wrapped around the stainless-steel pipe and service support with 50-mm overlap. The wrap was butt jointed together to form a total width of 600-mm with four 4.6-mm wide stainless steel cable ties securing the wrap at 50-mm from each end and 150mm centres. Any cut edges in the Twrap were sealed with aluminium reinforced tape.

The pipe projected vertically, 800-mm away from the unexposed face of the slab and approximately 500-mm into the furnace chamber. The pipe was supported at nominally 300-mm and 700-mm from the unexposed face of the concrete slab using support clamps. The pipe was open at the unexposed end and closed with 100-mm of ceramic fibre plug on the exposed end.

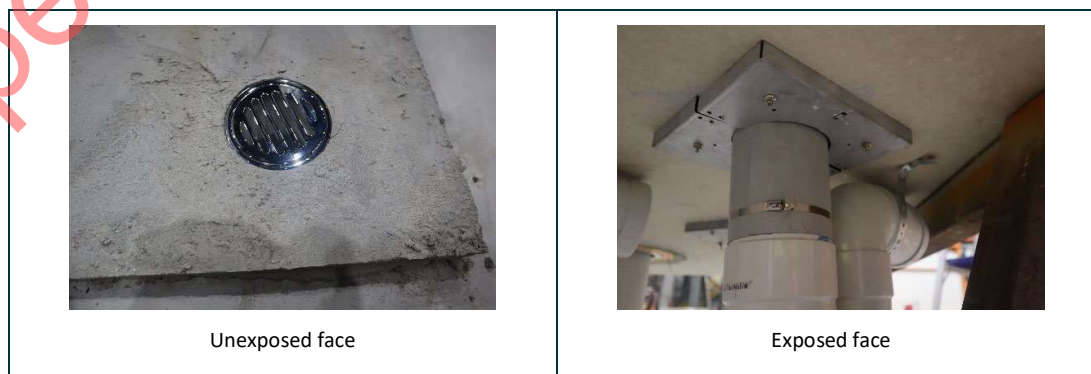
The penetrating service comprised an Iplex Pipelines DWV uPVC pipe with a 110-mm outside diameter and a wall thickness of 3-mm which penetrated the concrete slab through a 121-mm opening. On the exposed side of the slab, the pipe was fitted with two halves of the Trafalgar Springbox (with Pyrosafe DG cable bandage wrapped around the pipe first) and secured to the concrete slab using four M6 x 50-mm masonry anchors. A 137-mm wide Pyrosafe DG cable bandage was applied around the uPVC pipe with a 22-mm overlap in line with the slab. The Pyrosafe DG cable bandage was secured to the uPVC pipe using 4.6-mm wide stainless steel cable ties located 13-mm and 97mm from the exposed face of the concrete slab. As shown in drawing “CP34 V3” dated 17/10/2022, by Trafalgar Fire.

On the exposed side of the slab, a PVC P-trap was connected to the penetrating pipe with a coupling. The P-trap was capped with a PVC end cap and supported on the exposed face with 30-mm wide steel strapping fixed to the concrete slab using two M6 x 50-mm masonry anchors. The trap was charged with 1.5-L of water prior to testing. On the unexposed face of the concrete slab a floor waste system was fitted with a polypropylene puddle flange, an acrylonitrile-butadiene-styrene base and a chrome plated brass grate. A 30-mm thick sand and cement screed was laid on top of the concrete slab and finished flush with the grate.

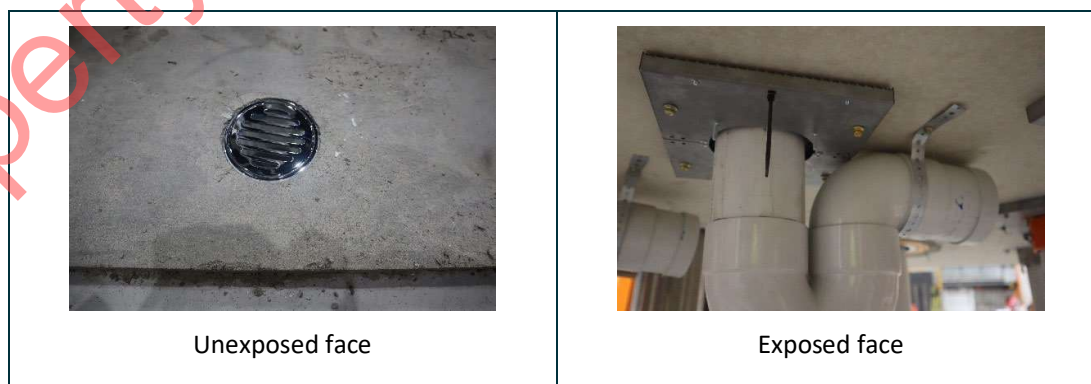
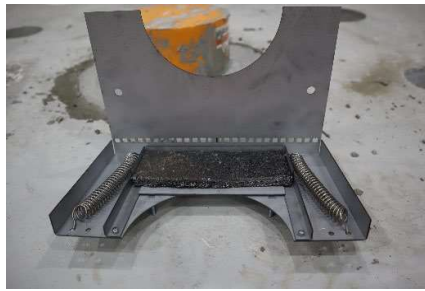
Springbox Internal

Specimen 8 – A Trafalgar ‘Springbox – Blade with Intumescent’ protecting a 100-mm diameter PVC pipe floor waste incorporating a P trap penetrating a 121-mm opening in the slab

The Trafalgar Springbox – Blade with intumescent was constructed from 1.1-mm mild steel plate and consisted of two symmetrical halves. Each half contained a baseplate measuring 140-mm wide x 120-mm long x 20-mm high. The top side of the baseplate contained a blade measuring 154-mm width x 69-mm length, with a 15-mm height flange. Each blade was lined with a Trafalgar Intumescent strip (730-kg/m³) measuring 55-mm wide x 150-mm long x 10-mm thick fitted with double sided tape. The blade was held into place with a 12-mm wide x 10-mm high x 137-mm long angles secured to the baseplate at the front by two 4-mm steel rivets and at the rear with two M5 x 20-mm press studs. Each blade contained a tensioned spring secured to the baseplate with the blade being pulled back to the rear and the blade held into place with 3.6-mm wide x 1.4-mm thick plastic cable ties as shown in drawing “Springbox – Blade with intumescent” dated 18/10/2022, by Trafalgar Fire.

The penetrating service comprised an Iplex Pipelines DWV uPVC pipe with a 110-mm outside diameter and a wall thickness of 3-mm which penetrated the concrete slab through a 121-mm opening. On the exposed side of the slab, the pipe was fitted with two halves of the Trafalgar Springbox (blade with intumescent) and secured to the concrete slab using four M6 x 50-mm masonry anchors as shown in drawing “CP34 V3” dated 17/10/2022, by Trafalgar Fire.

On the exposed side of the slab, a PVC P-trap was connected to the penetrating pipe with a coupling. The P-trap was fitted with a PVC end cap and supported on the exposed face with 30-mm wide steel strapping fixed to the concrete slab using two M6 x 50-mm masonry anchors. The trap was charged with 1.5-L of water prior to testing. On the unexposed face of the slab a floor waste system was fitted with a polypropylene puddle flange, an acrylonitrile-butadiene-styrene base and a chrome plated brass grate. A 30-mm thick sand and cement screed was laid on top of the concrete slab and finished flush with the grate.

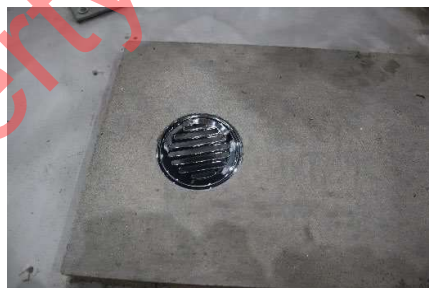
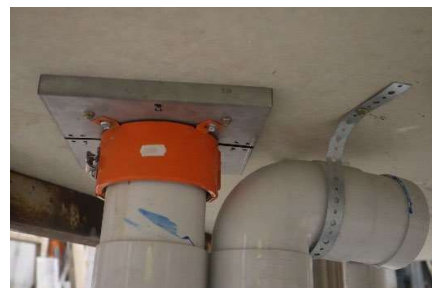
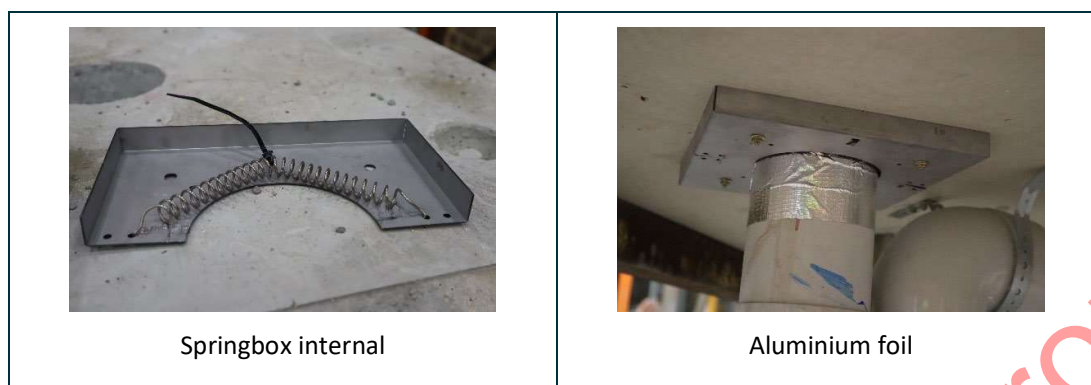
Specimen 9 – A Trafalgar ‘Springbox with foil tape’ and Fyrecollar protecting a 100-mm diameter PVC pipe with floor waste incorporating a P trap penetrating a 121-mm opening in the slab

The penetrating service comprised an Iplex Pipelines DWV uPVC pipe with a 110-mm outside diameter and a wall thickness of 3-mm which penetrated the concrete slab through a 121-mm opening. On the exposed side of the slab, a 95-mm wide aluminium reinforced foil tape was applied around the uPVC pipe with a 22-mm overlap in line with the slab. The Springbox with foil tape and FyreCOLLAR was secured to the exposed face of the concrete slab using four M6 x 50mm masonry anchors as shown in drawing “CP34 V3” dated 17/10/2022, by Trafalgar Fire.

On the exposed side of the slab, a PVC P-trap was connected to the penetrating pipe with a coupling. The P-trap was plugged with a PVC end cap and supported on the exposed face with 30-mm wide steel strapping fixed to the concrete slab using two M6 x 50-mm masonry anchors. The trap was charged with 1.5-L of water prior to testing. On the unexposed face of the slab a floor waste system was fitted with a polypropylene puddle flange, an acrylonitrile-butadiene-styrene base and a chrome plated brass grate. A 30-mm thick sand and cement screed was laid on top of the concrete slab and finished flush with the grate.

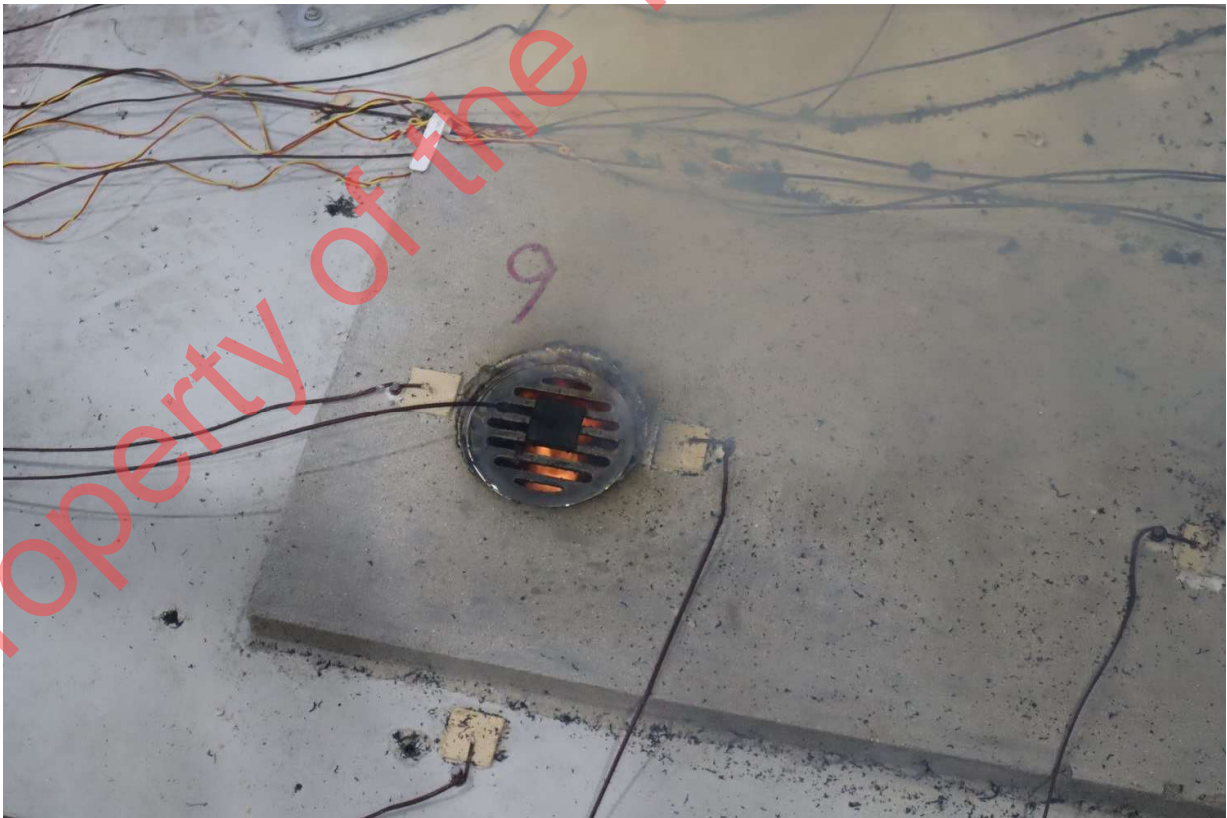
PHOTOGRAPH 6 – SPECIMEN 9 AFTER 117 MINUTES OF TESTING

- 117 minutes - The collar of specimen 9 appears to have fallen off, furnace chamber is visible through the grate (photograph 6).
- 119 minutes - Integrity Failure of Specimen 9 - Cotton pad test applied to Specimen 9 – Ignition noted at this time.

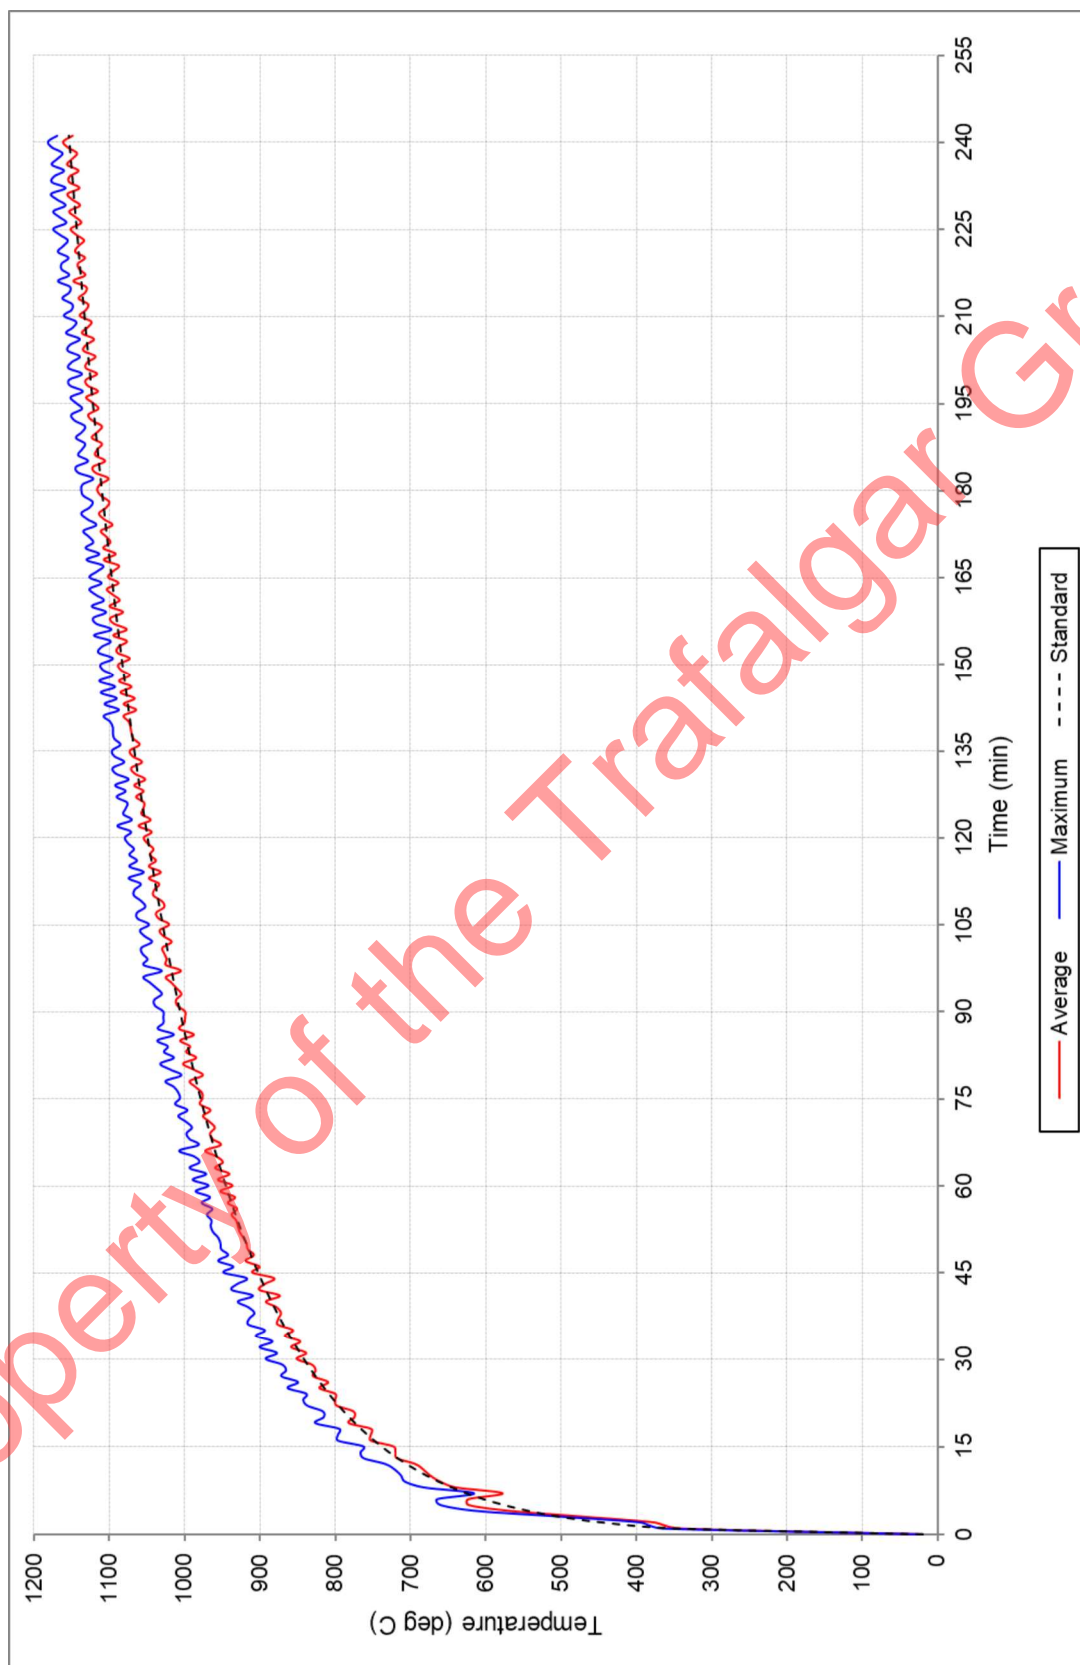
FIGURE 1 – FURNACE TEMPERATURE

The temperature in the furnace chamber was measured by four type K, 3-mm diameter, and 310 stainless steel Mineral Insulated Metal Sheathed (MIMS) thermocouples. Each thermocouple was housed in high-nickel steel tubes opened at the exposed end.

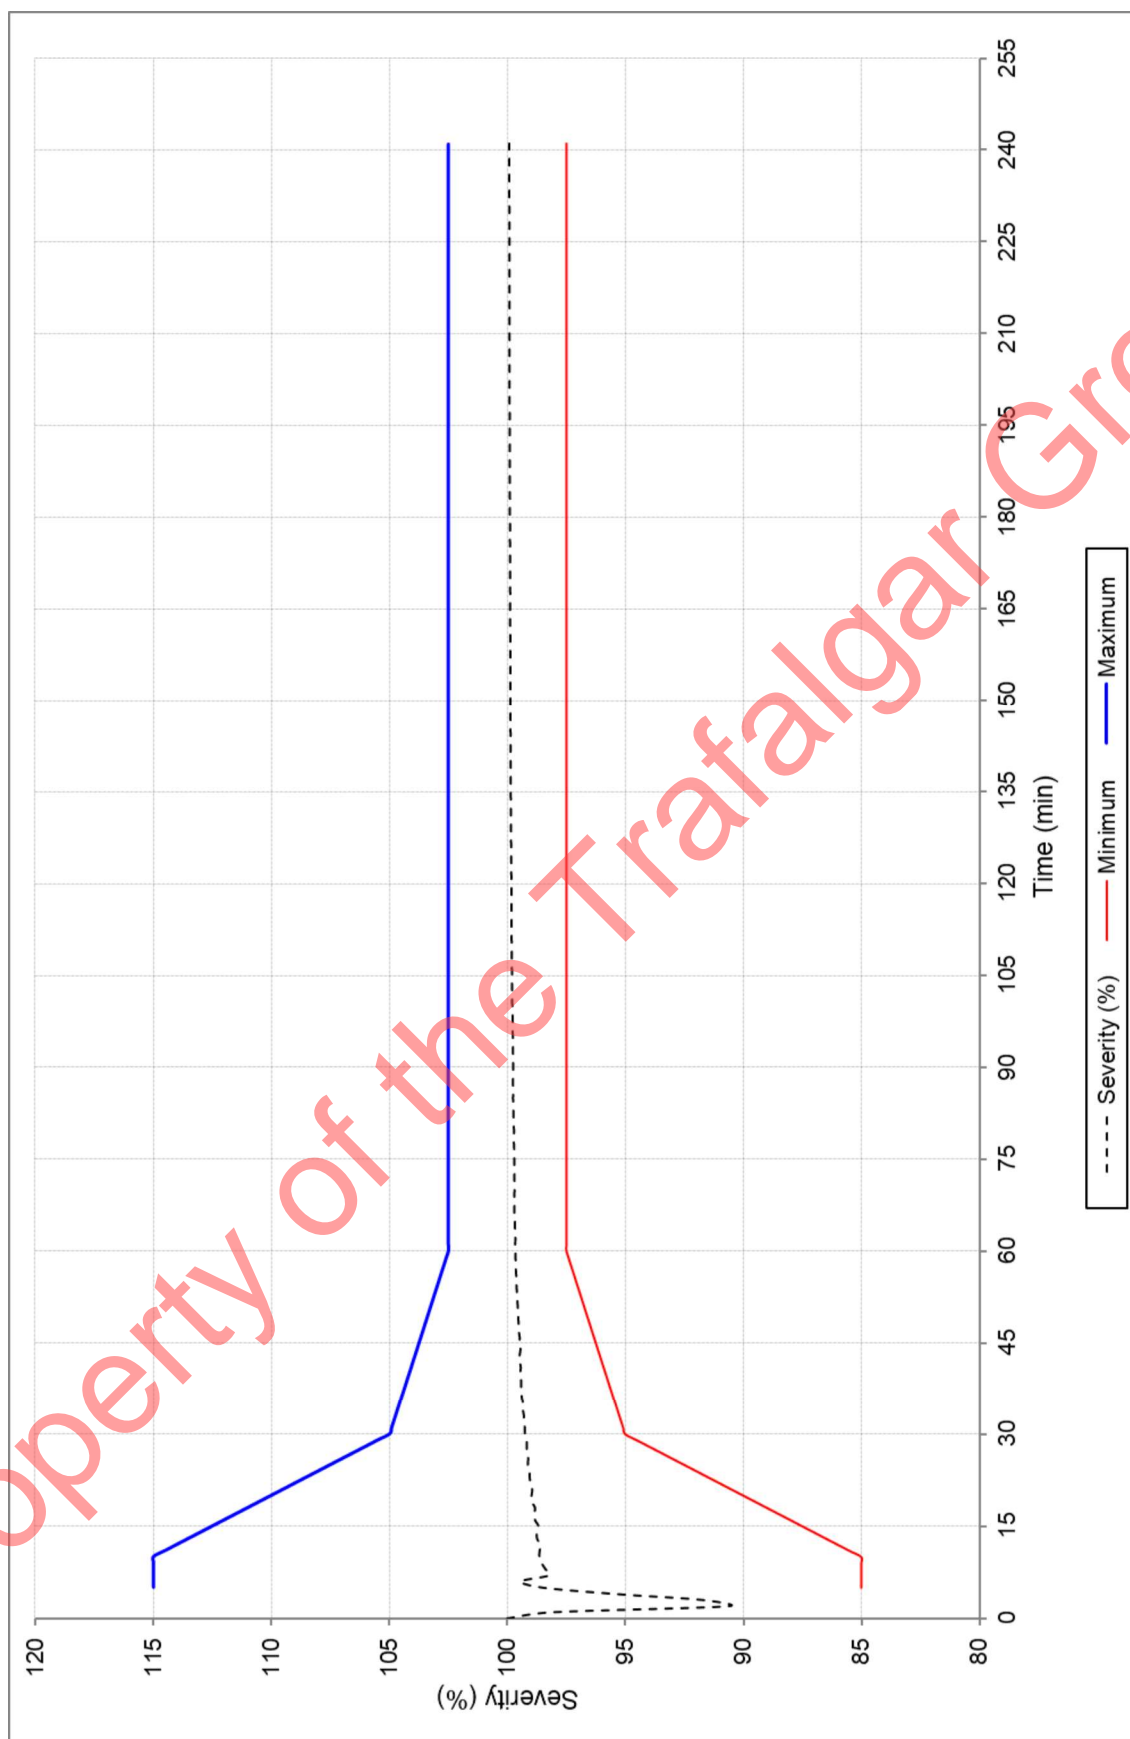
FIGURE 2 – FURNACE SEVERITY

Figure 2 shows the curve of furnace severity versus time during the heating period.

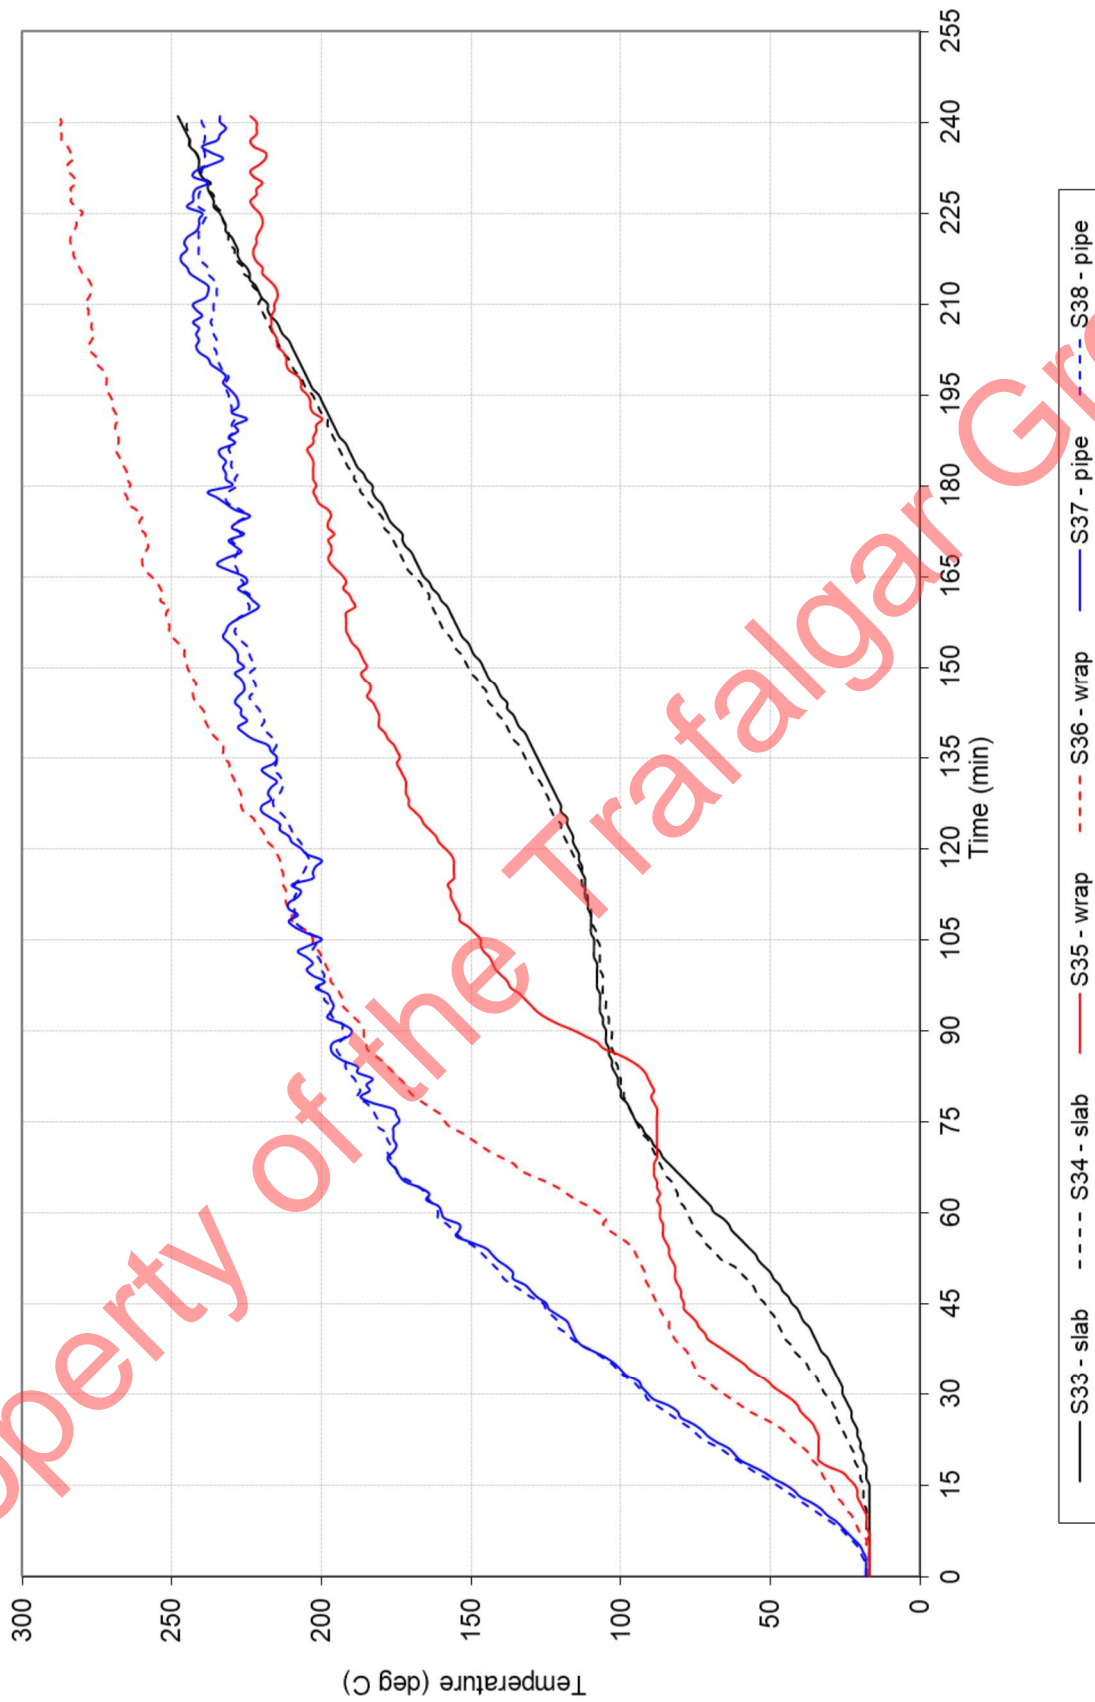
FIGURE 9 – TEMPERATURE VERSUS TIME ASSOCIATED WITH SPECIMEN 6

- 95 minutes - Insulation Failure of Specimen 6 – Maximum temperature rise of 180 K on the stainless-steel pipe.
- 106 minutes - Cotton pad test applied to the floor waste grate of Specimen 9 – No ignition noted at this time.

Structural adequacy	-	not applicable
Integrity	-	no failure at 241 minutes
Insulation	-	95 minutes

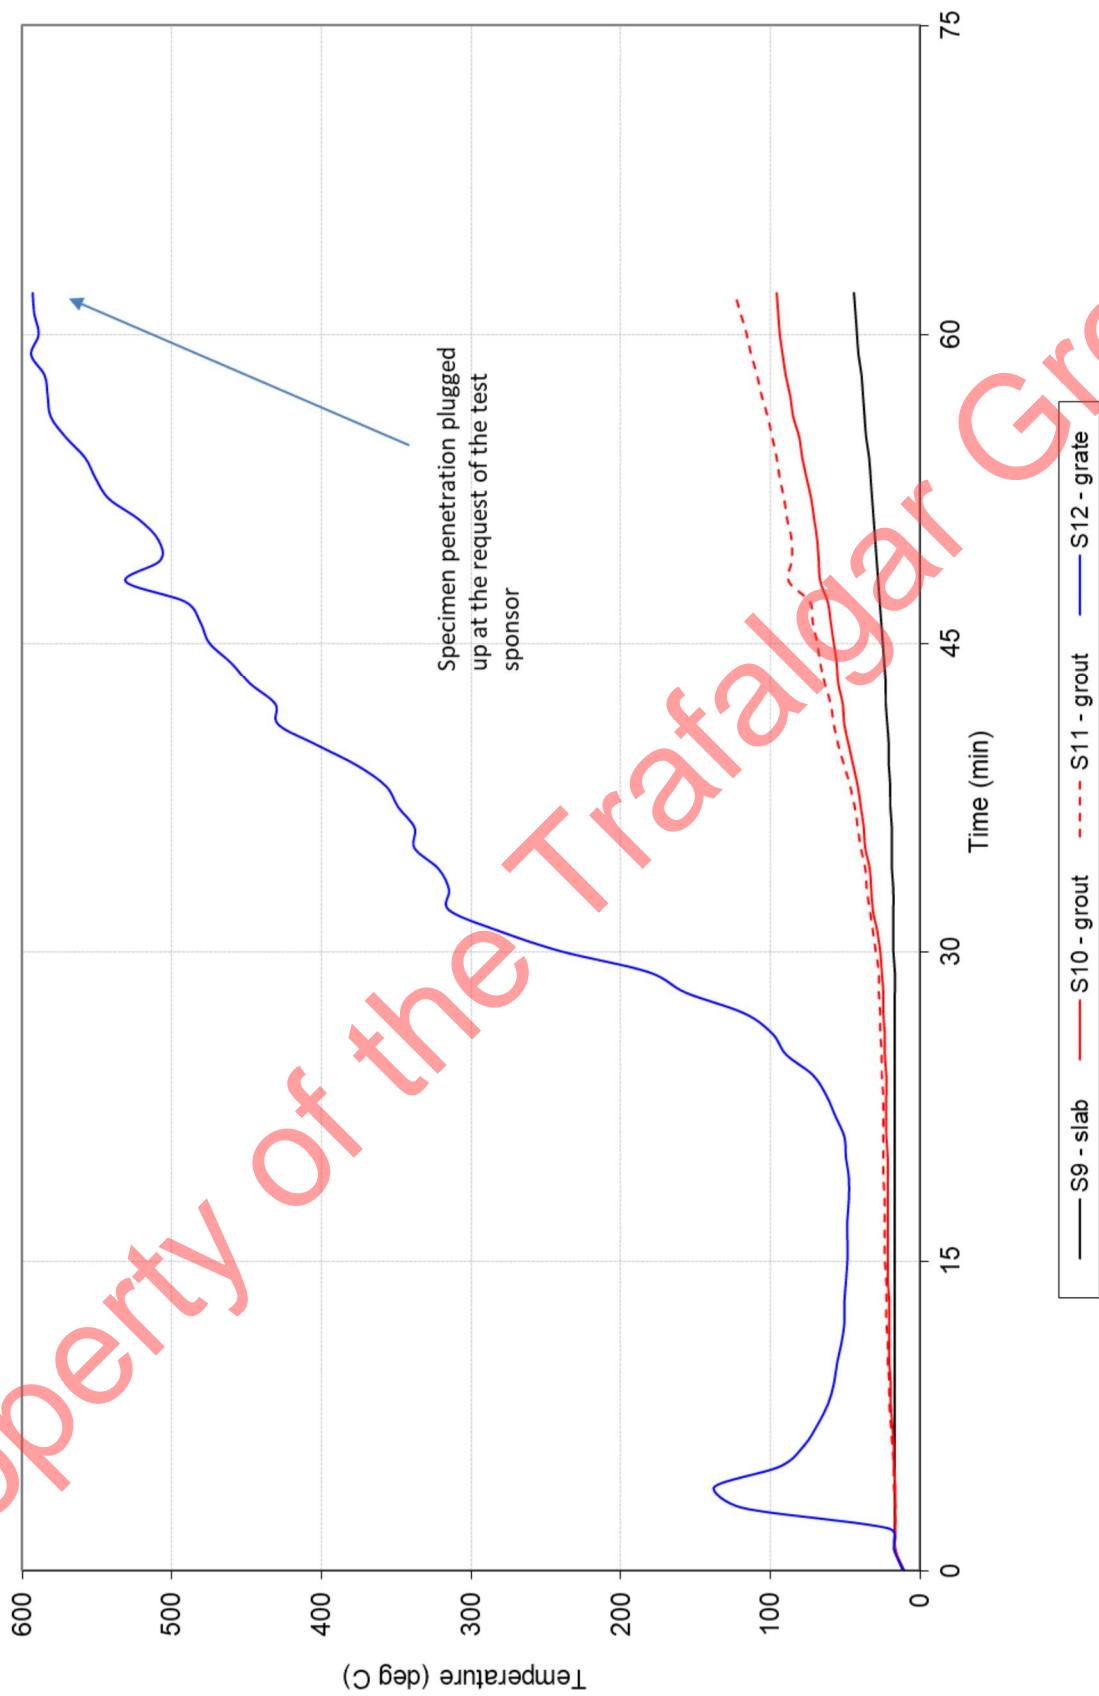
FIGURE 10 – TEMPERATURE VERSUS TIME ASSOCIATED WITH SPECIMEN 7

- 30 minutes - Cotton pad test applied to the floor waste grate of specimen 7 – No ignition noted at this time.
Insulation Failure of Specimen 7 – Maximum temperature rise of 180 K on the floor waste grate.

- 47 minutes - Integrity Failure of Specimen 7 - Cotton pad test applied to specimen 7 – Ignition of cotton pad noted at 48 minutes.
- 48 minutes - Insulation failure of Specimen 2 – Maximum temperature rise of 180 K on the PVC pipe.

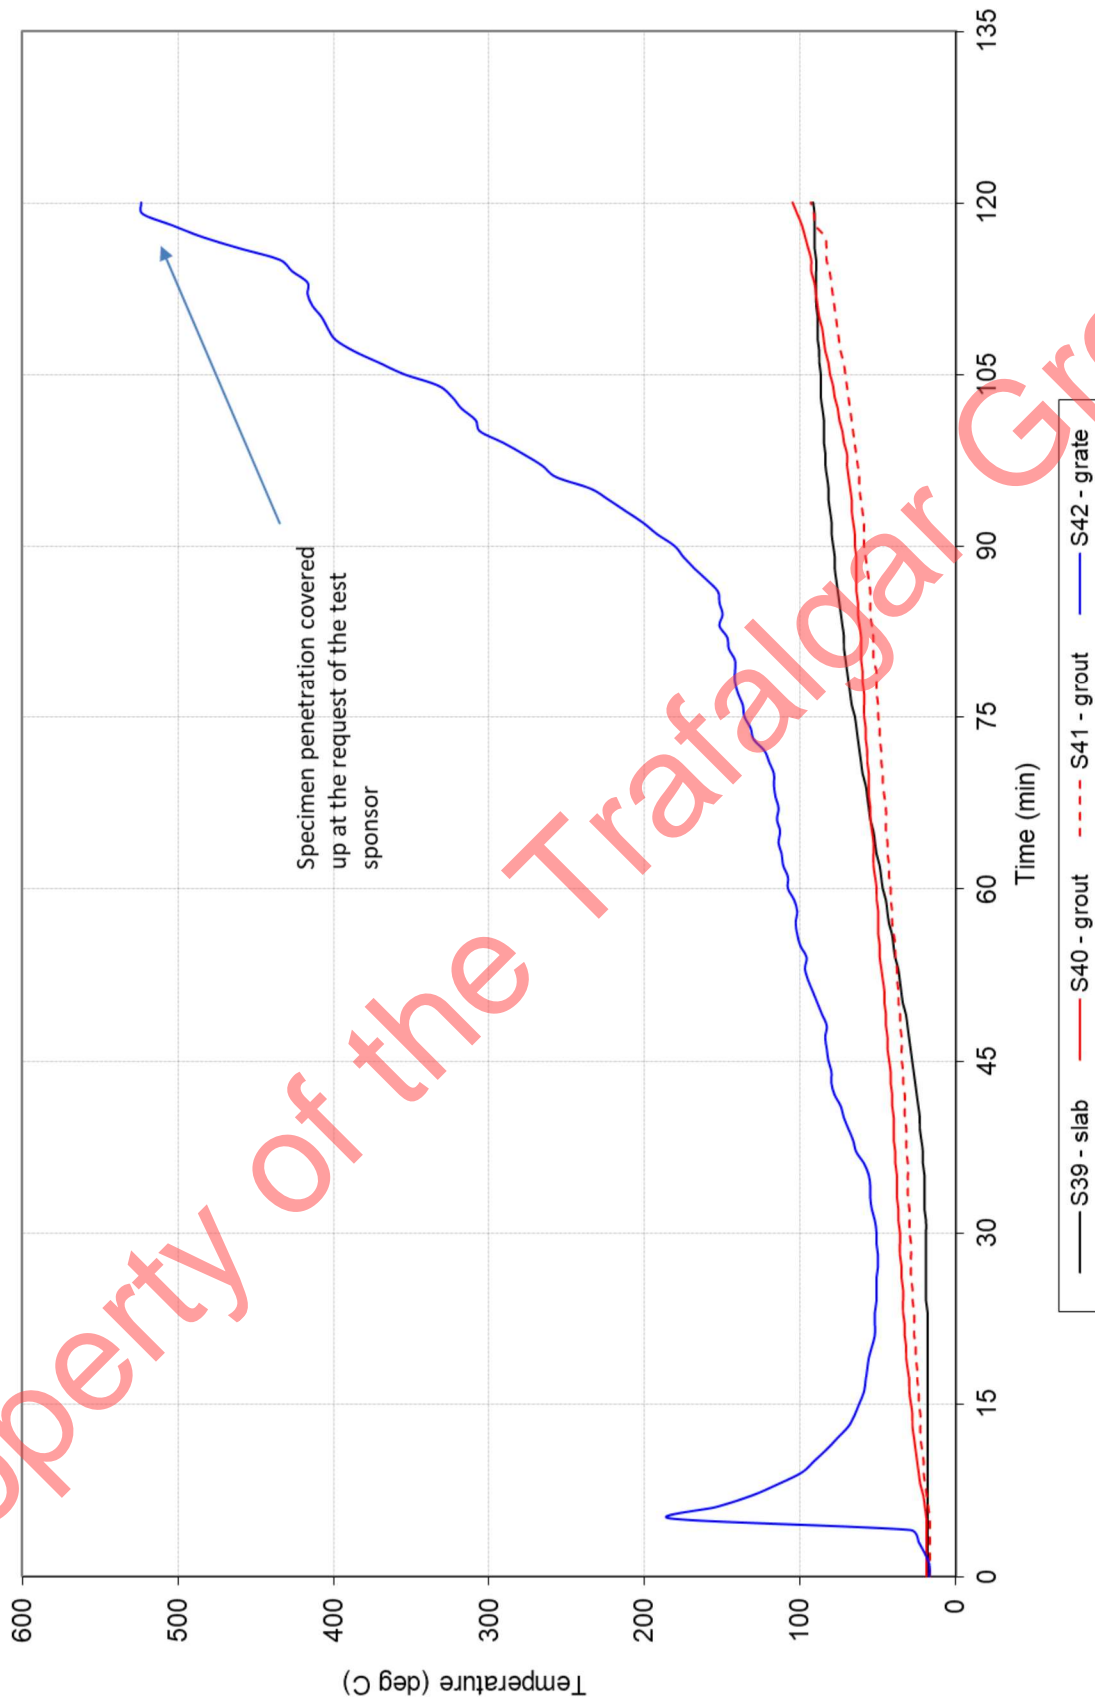
FIGURE 12 – TEMPERATURE VERSUS TIME ASSOCIATED WITH SPECIMEN 9

- 84 minutes - The sealant at the base of specimen 6 is swelling up.
- 92 minutes - Insulation failure of Specimen 9 - Maximum temperature rise of 180 K on the floor waste grate.
